Arborist Associates Ltd

An Arboricultural Assessment on the Site Area at "Ballinahinch", Ashford, Co Wicklow.

Prepared for: Wicklow County Council.

Date: 19th March 2024

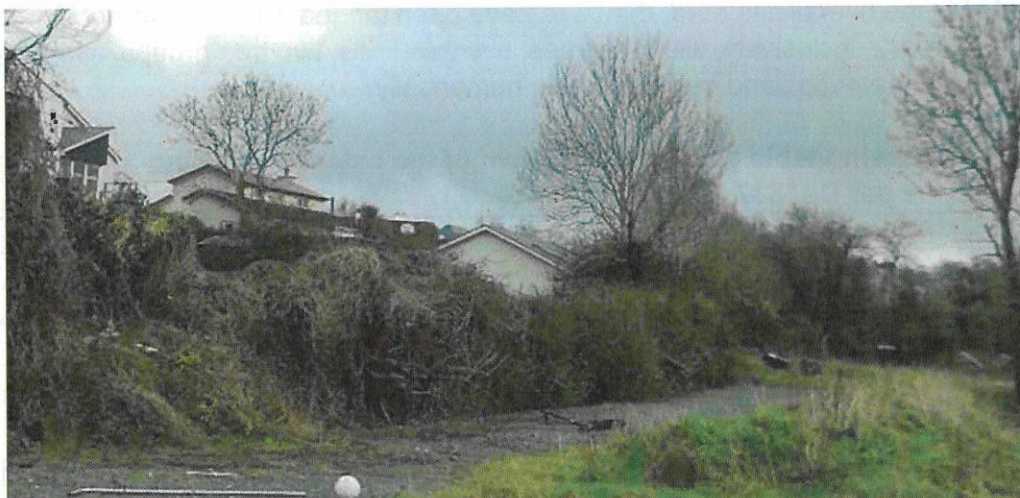
Photograph No. 1: Shows Hedge No.1 along part of the northern boundary.

- To facilitate the proposed development, it is necessary to remove Hedge No.1, Tree Line No.2 and Tree Nos.1840, 1841 & 1842 directly due to the development layout. It will also be necessary to trim in the encroaching vegetation from Woodland Belt No.1 to facilitate the perimeter path.

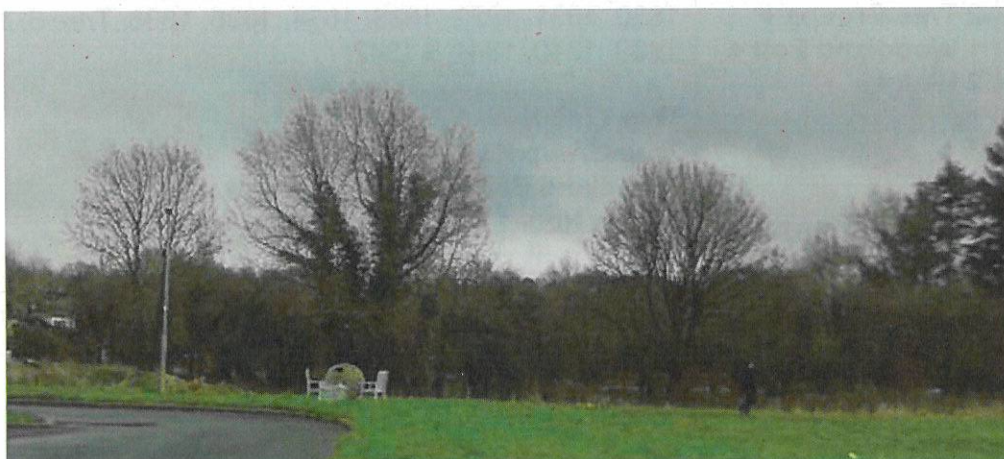
Photograph No. 2: Shows Hedge No.2 running along the site eastern boundary.

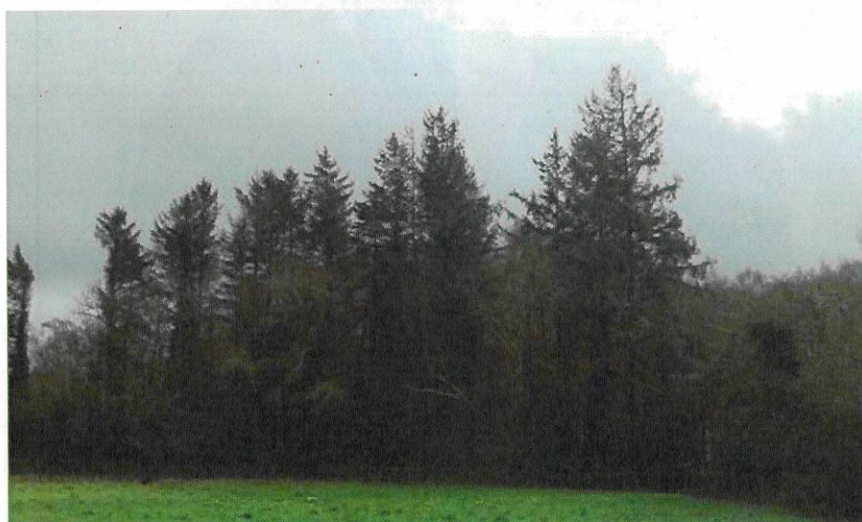
Photograph No. 3: Shows Tree Line No.1 and Woodland Belt No.1 in the background along the site southern boundary.

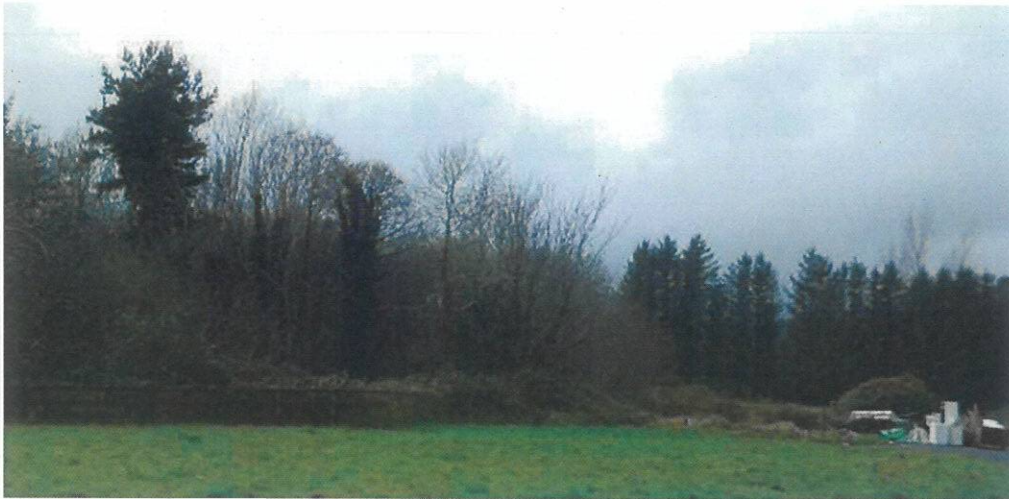
Photograph No. 4: Shows another view of Woodland Belt No.1 looking from east to west.

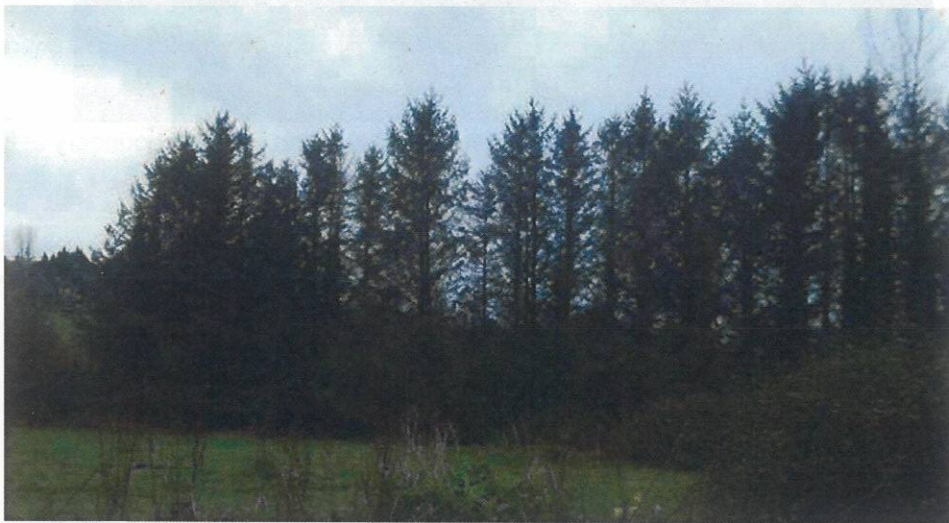
Photograph No. 5: Shows Tree Line No.2. along the sites western boundary.

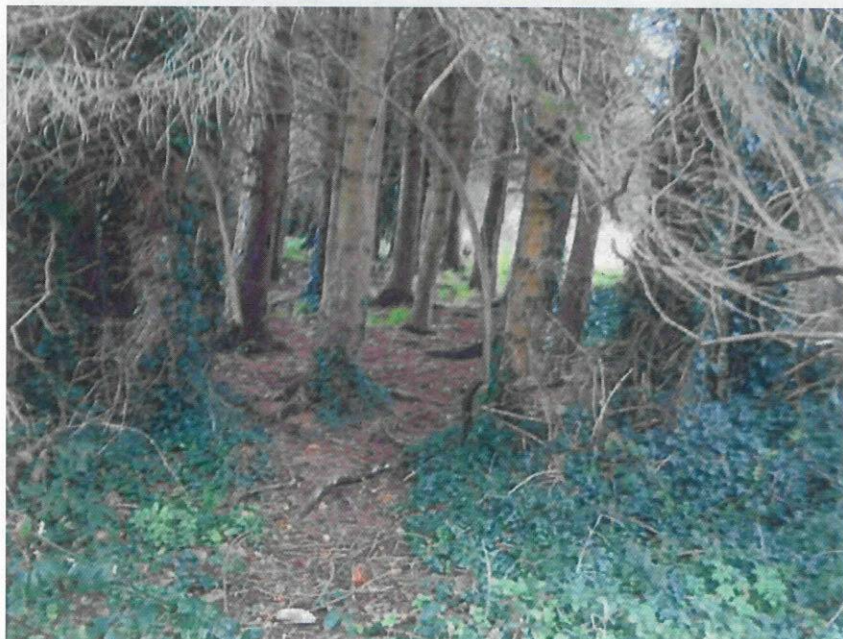
Photograph No. 6: Shows the close spacing of the trees within Tree Line No.2 and the area underneath the trees.

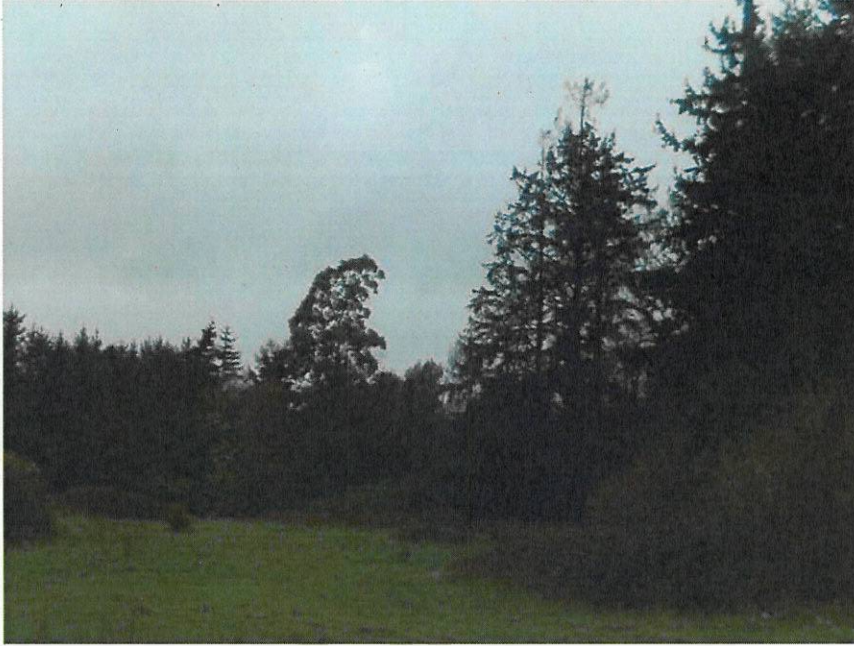
Photograph No. 7: Shows a view of the trees along the northern boundary at the western end of the site area.

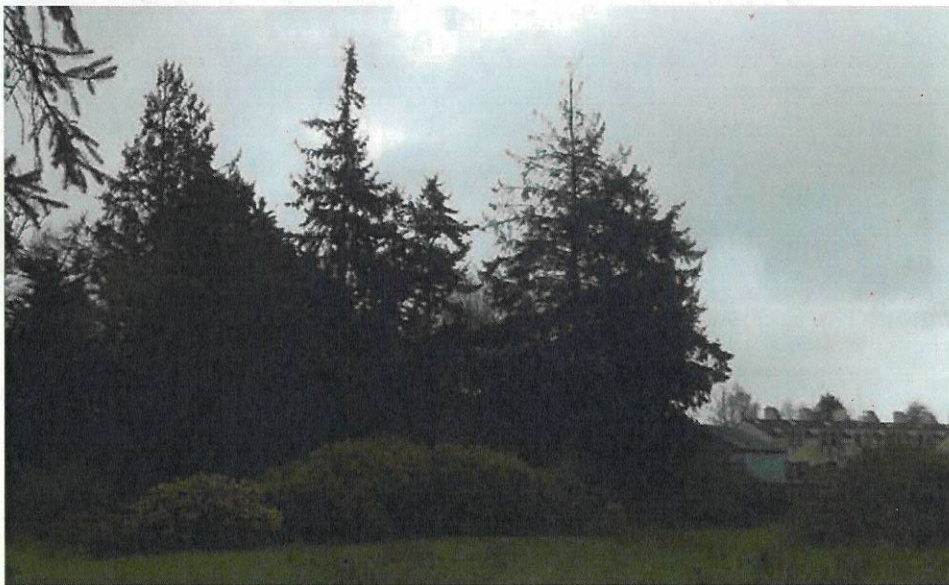
Photograph No. 8: Shows Tree Group No.1.
