RE: Declaration in accordance with Section 5 of the Planning & Development Acts 2000 (As Amended) – EX82/2024

DECLARATION IN ACCORDANCE WITH ARTICLE 5 (2) (A) OF THE PLANNING & DEVELOPMENT ACT 2000 AS AMENDED

Conservation Engineers Report
Bell Tower, St Patrick's Loreto Primary School,
Vivay Road, Bray, County Wicklow
NIAH register number 16301070
Protected Structure number B105

Project: Bell Tower, St Patrick's Loreto Primary School
Client: St Patrick's Loreto Primary School
Reference: 24-22
Date: 25th July 2024

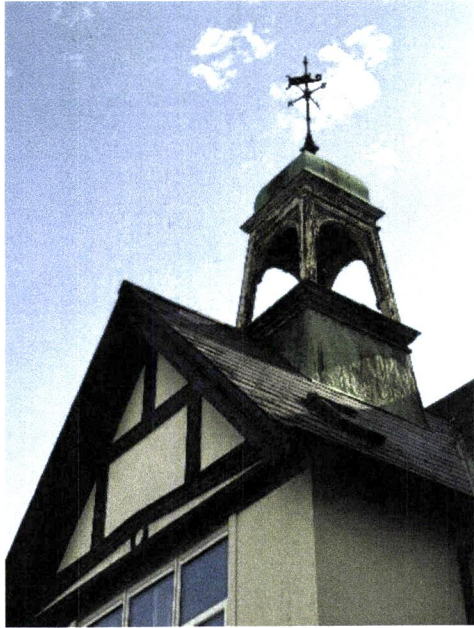
Photograph 1: Bell Tower

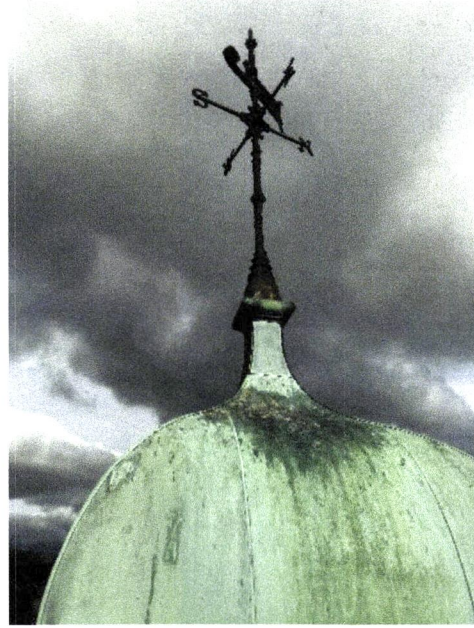
On top of the copper roof is a cast iron weathervane that no longer operates as its bearing has seized. See photograph 2. It should be noted that there is currently no lightning conductor to this roof, which based on the fact this bell tower is the highest point of the building and other buildings in close proximity, we would recommend that during remedial works a lightning conductor is installed with cabling to ground.

Photograph 2: Roof to bell tower with seized up weathervane.

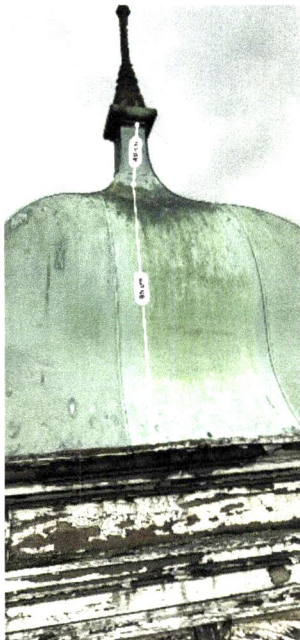
Photograph 3: Copper cladding to roof of bell tower and decorative timber under

Just below the copper roof we are of the opinion that a code 4 or 5 lead flashing or similar material be added to prevent water ingress and water laying on top of horizontal timber members then causing rot.

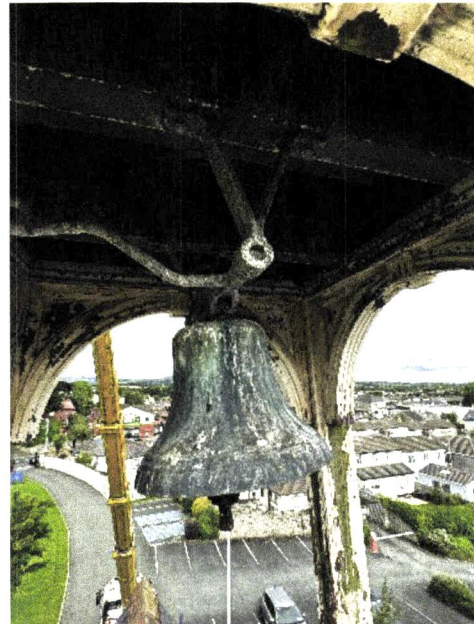
Photograph 4: View to underside of bell tower roof steel bell supports and timber cladding to ceiling

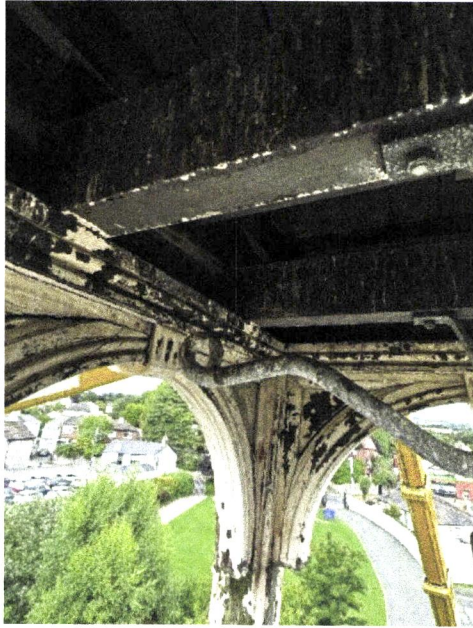
Photograph 5: Steel bell support onto timber side framing

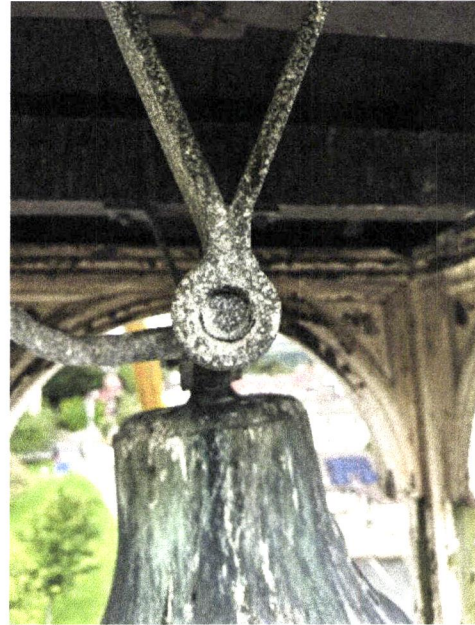
Photograph 6: Seized bell support

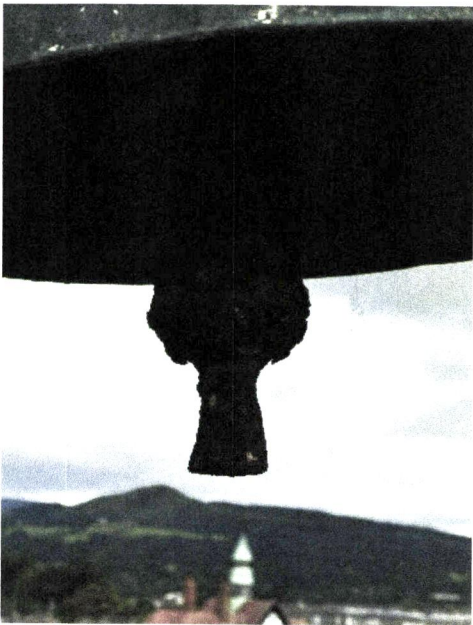
Photograph 7: Seized hammer to bell

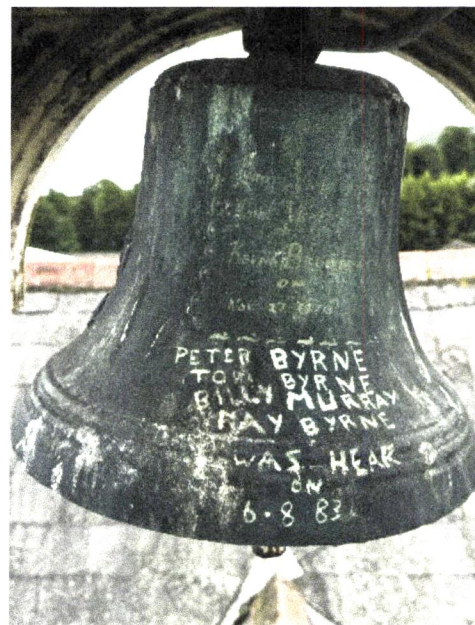
There is evidence of the bell, possibly bell tower as well, having had previous maintenance work undertaken in 1970 and 1983 from inscriptions on the bell which are common traits when such works are undertaken. See photograph 8. The actual roof structure is in a good structural condition with only some minor maintenance required. Consideration should be given to refurbishment of both the wind vane and bell mechanism to make these operational again.

Photograph 8: Inscriptions on bell from potential previous works / repairs

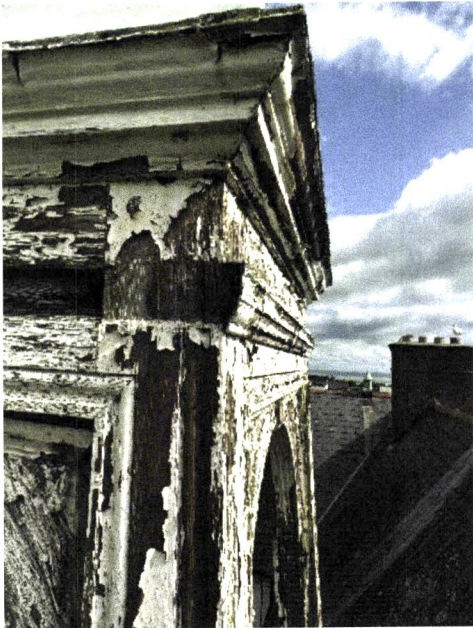
Photograph 9: Decorative timber facing paint spalling and some rot in timber

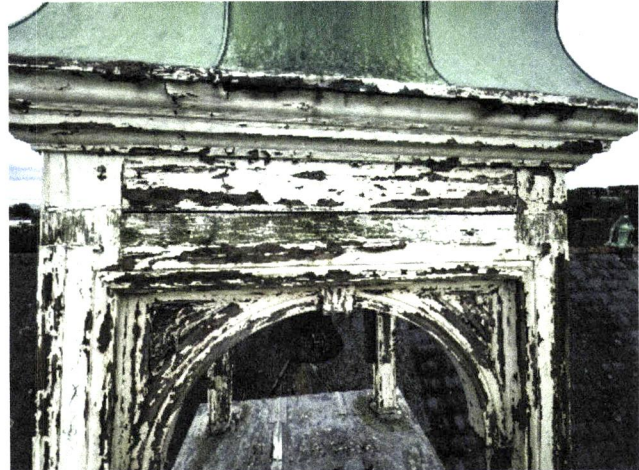
Photograph 10: Spalling of paint to decorative timber and signs of rot in horizontal member.

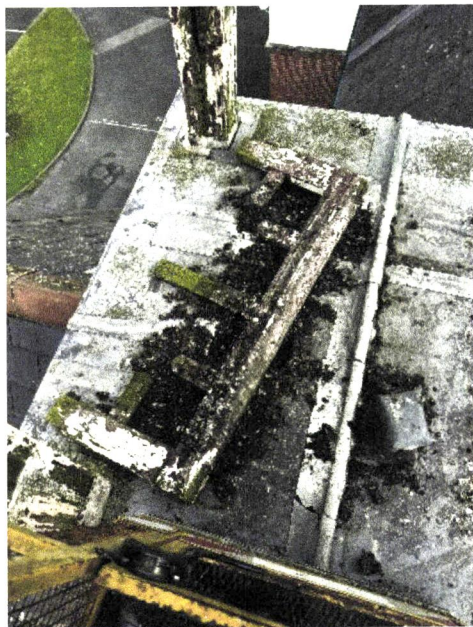
Some of the decorative timber has previously dislodged and one sole remaining section of what would have been part of a bottom decorative timber shroud is now sitting detached from the bell tower on the flat dais. See photograph 11. It is questionable whether this should be fully reinstated as it is not entirely visible from ground level, and due to the fact that this solitary piece remains and is in an advanced state of decay, would indicate any replacement would have a similar fate in years to come. The majority of the decorative timber is in various states of disrepair with approximately 50% requiring replacement due to rot and the remaining 50% requiring paint removal and fully coating with an external durable paint system. See photographs 12 to 15.

Photograph 11: Original section of decorative timber skirt to bell tower

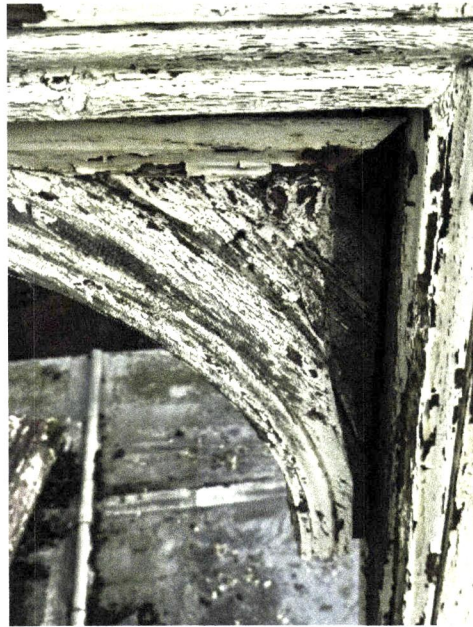
Photograph 12: Close up of decorative timber element corner detail

With regards to the decorative timber this is at various stages of degradation with some sections missing. Our recommendation is to remove the decorative timber elements and refurbish / repair elements that can be repaired with any rotten sections replaced with new treated timber. All then painted with suitable long-lasting paints and re installed using copper nails to provide

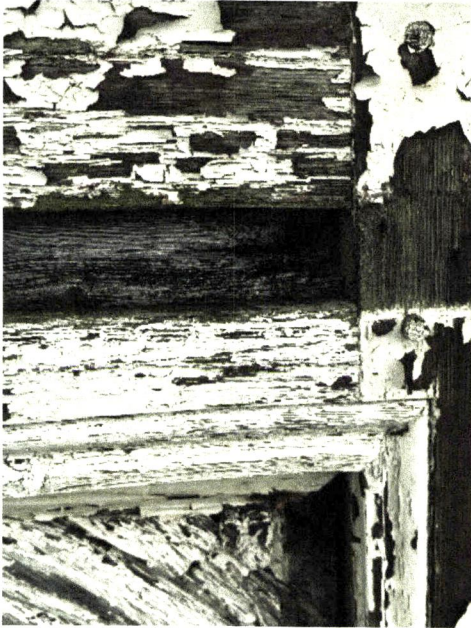
Photograph 13: Rot in decorative timber and structural horizontal member behind

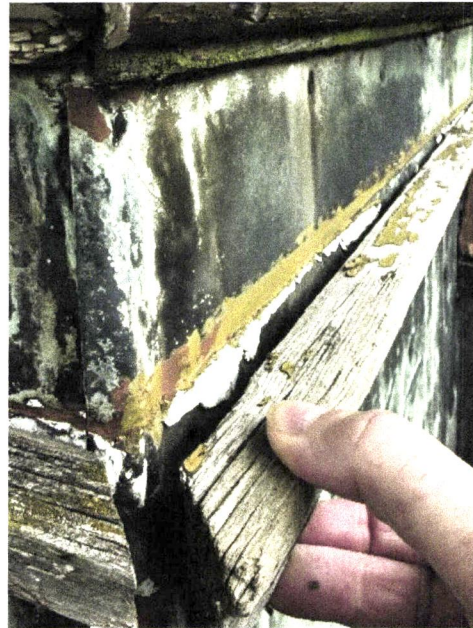
Photograph 14: Loose timber to copper shroud on dais support to bell tower

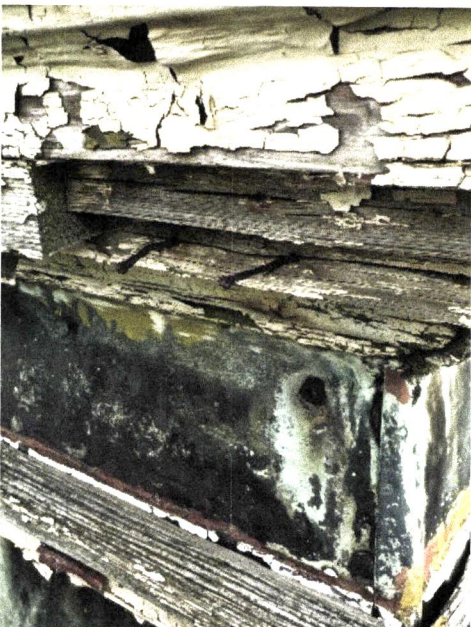
Photograph 15: Missing decorative timber and rot noticeable on timber behind

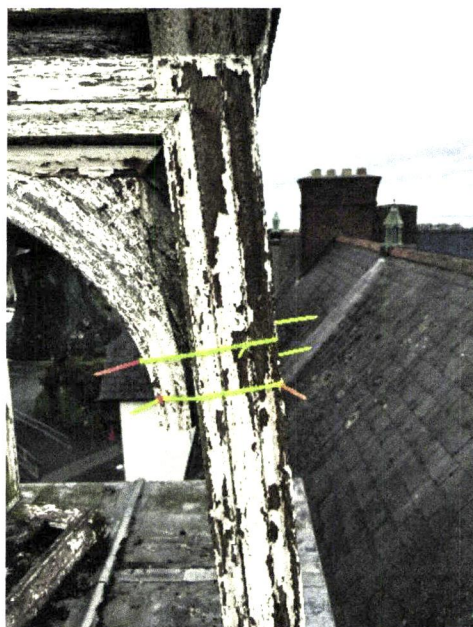
The decorative timber immediately under the copper roof is actually causing water to penetrate to the main structural timbers. The south elevation, where the decorative timber has fallen off the horizontal main timber, has rot towards its western side and will need a new piece of timber splicing onto the scarf joint due to rot having occurred. For the horizontal structural timbers, we would allow for 20% replacement / splicing. We would also recommend at this higher level some form of either copper / zinc or code 4 or 5 lead covering to reduce the risk of water being able to penetrate to the main bell tower horizontal support timbers. One section of decorative timber has become loose and in danger of falling off the bell tower. It was not possible to remove this while undertaking the inspection but a number of brightly coloured cable

Photograph 16: Loose timber with temporary fixings to secure

ties were used to temporarily secure it from falling. See photograph 16. This section should be either temporarily removed or secured further until such time as full remedial work to the bell tower is undertaken. One decorative element only remains to one post and consideration should be given to temporarily removing this to create a template for re-forming the missing three for reinstatement. See photograph 17.

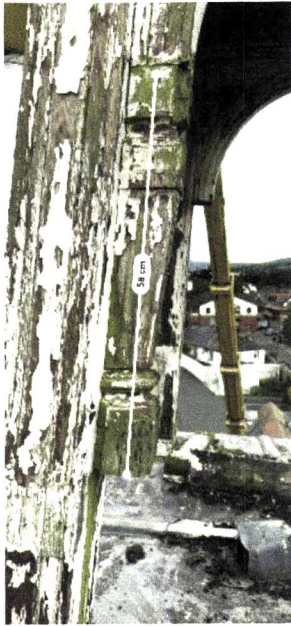
Photograph 17: Single section of lower decorative element that could have moulding taken for reinstatement onto other three posts

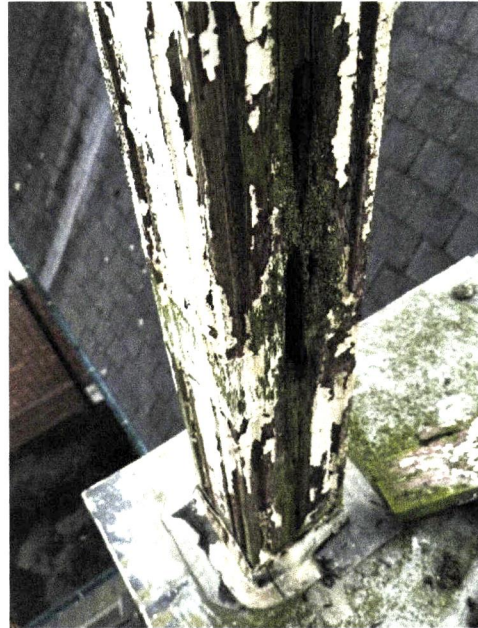
The supporting oak timber posts are generally in a reasonably good condition structurally but will require total repainting. One post in the Northwest corner has a small amount of rot / degradation at its base and this will require removal and a new piece of oak timber scarf jointed into the remaining post. See photograph 18. At the base of each post is a lead flashing that then sits on top of the flat dais roof. We could not determine how these posts are connected to the flat dais roof from outside. Attempts to view this area from within the attic proved impossible due to lack of adequate access to the attic space. There was also a potential issue noted on looking through the very narrow access hatch that would require a full asbestos survey to be undertaken to determine its presence or otherwise.

Photograph 18: Base to Northwest post showing rot and degradation of timber.

Structurally, the main issue was some rot in one of the supporting oak legs to the bell tower on the northwest corner that has suffered some rot at low level. The rotten section requires removal and splicing in with a scarf joint a new section of oak timber. At the higher level, just under the level of the copper roof, one horizontal member behind a section of rotten decorative timber has also suffered rot that will require a section of this member to be cut and spliced with new treated timber.

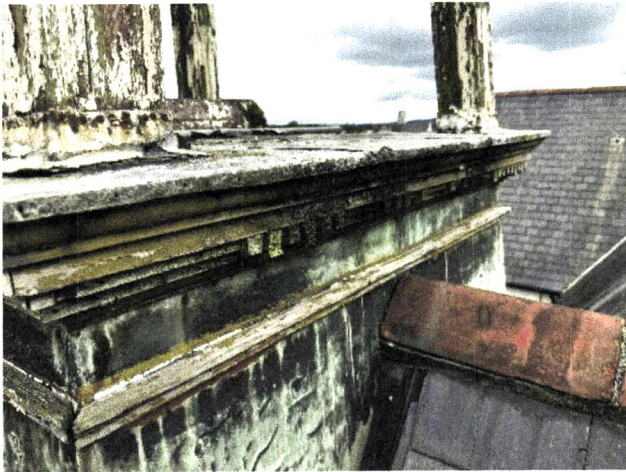
The flat dais support roof joins onto the pitched roof at the front of the school in this area. The sides of the dais are covered in copper cladding that have then been embellished with timber. See photographs 19-22. The lower decorative timber piece has been attached using steel nails which have suffered bi-metallic corrosion having come into contact with the copper cladding. Small timber dentil details are also rotting and failing at the underside of the fluted timber finish immediately below the flat dais.

Photograph 19: Decorative timber attached to copper cladding on dais walls

We would recommend the removal of both of these elements and the remains of any fixings associated with these two details. The lower timber could be replaced with a more durable mould, affixed with copper nails, and the dentils would not be recommended to be replaced in timber which would probably mean not reinstating them at all. Based on the fact they have been nailed into

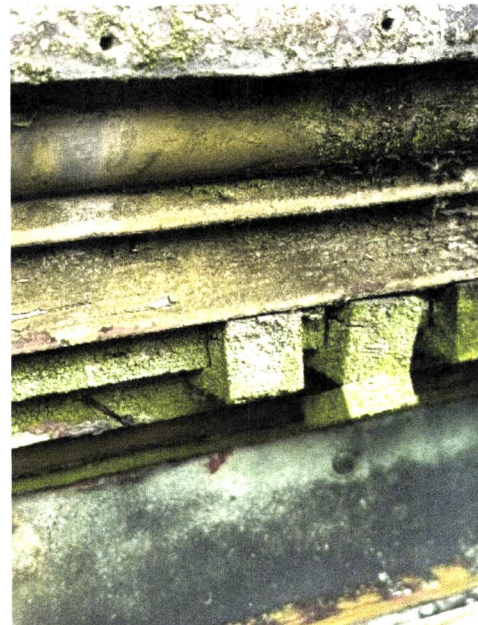
Photograph 20: Close up of timber dentil pieces with missing dentil pieces and one about to fail

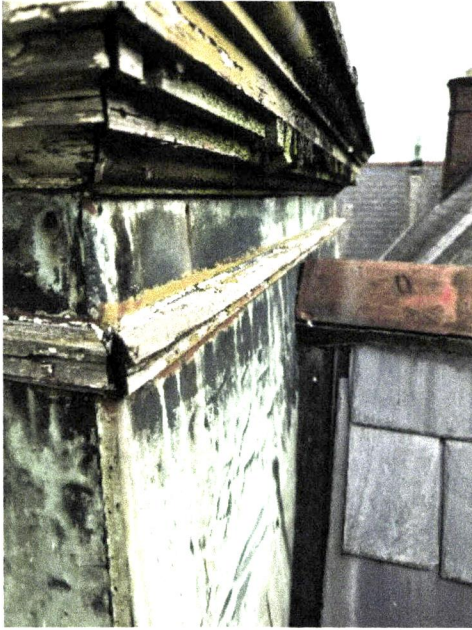
A decision will need to be made with regards to the decorative timber added below the flat supporting dais. At this location timbers have been nailed through the copper cladding with incompatible nails that have suffered advanced corrosion / failure with the timber also rotten. Our belief is the elements of this timber are not part of the original structure and were placed as embellishments during works that appear to have occurred in the 1970's and late 1980's.

Photograph 21: Further view of dentil pieces missing and lower timber loose with nail failures

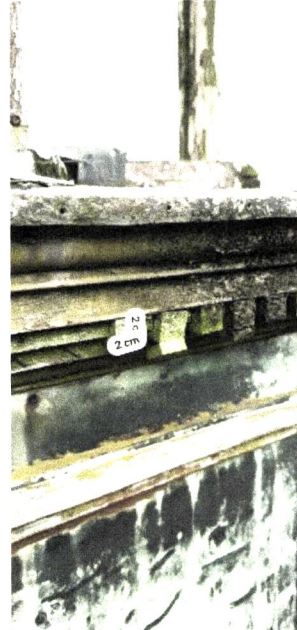
Photograph 22: Timber feature on dais walls over copper cladding
