RE: Declaration in accordance with Section 5 of the Planning & Development Acts 2000 (As Amended) - EX68/2024 - Legionaries of Christ, Dublin Oak Academy, Bray

## DECLARATION IN ACCORDANCE WITH ARTICLE 5 (2) (A) OF THE PLANNING & DEVELOPMENT ACT 2000 AS AMENDED

**Re. Emergency Works, Repairs and Renewals required to Kilcrouney House at Dublin Oak Academy, Kilcrouney House, Bray, Co. Wicklow A98T021.**

**3.0 Description of urgently required Repairs and Renewals to Kilcrone House for which we seek a Section 5 Declaration of Exemption:**

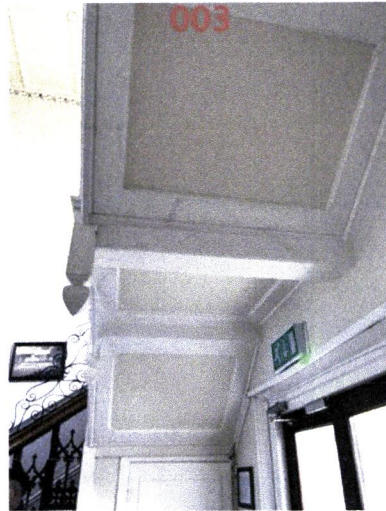
Photo 003

Careful removal of plaster to wall to open-up and inspect where the timber cantilever is bedded into external wall has been carried out. The timber cantilever was found to be requiring additional support but was not found to be rotten.

A new steel angle has been installed as per S.E., O'Brien Consulting Engineers, specification. O'Brien Consulting Engineers are currently designing a prop to support the staircase in the longer term.

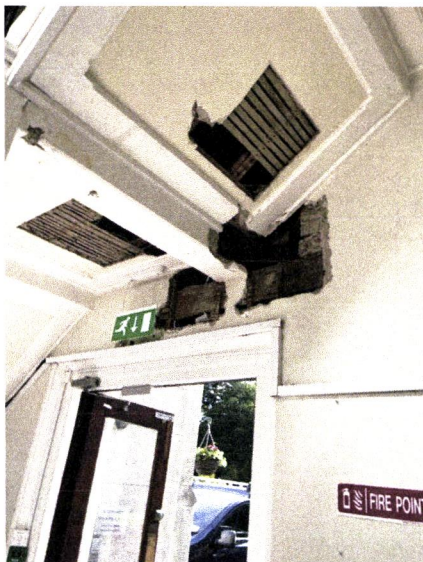
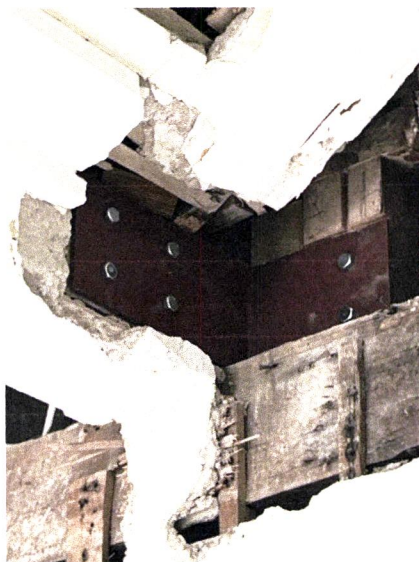
Kilcrone House Entrance Hall - Photos June 2024

Staircase opened-up and Steel angle inserted behind lining.

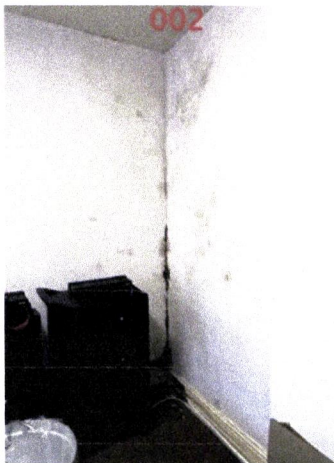
Deans Room Photo 002.

3.2.1 The Deans room, at first floor level in Kilcrouney House, had a significant damp problem in one corner.

3.2.2 The source of the moisture was identified as a leaking lead valley, gutter and downpipe overhead.

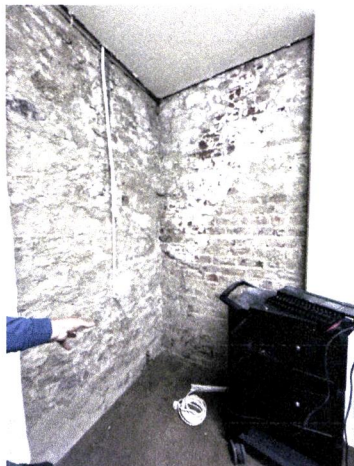
Dean's Room (first floor) lime plaster stripped back and walls treated for Rot Photo taken 06-06-2024.

3.2.4 Execution of Quigley Preservation Wet/Dry Rot Protocol.

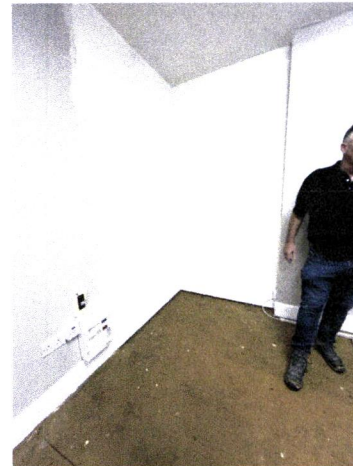
Dean's Room - Diathonite Lime and cork. Photo taken 16-07-2024.

3.2.5 Installation of Diathonite cork and lime plaster by David Broderick Lime Plasterer/equivalent.

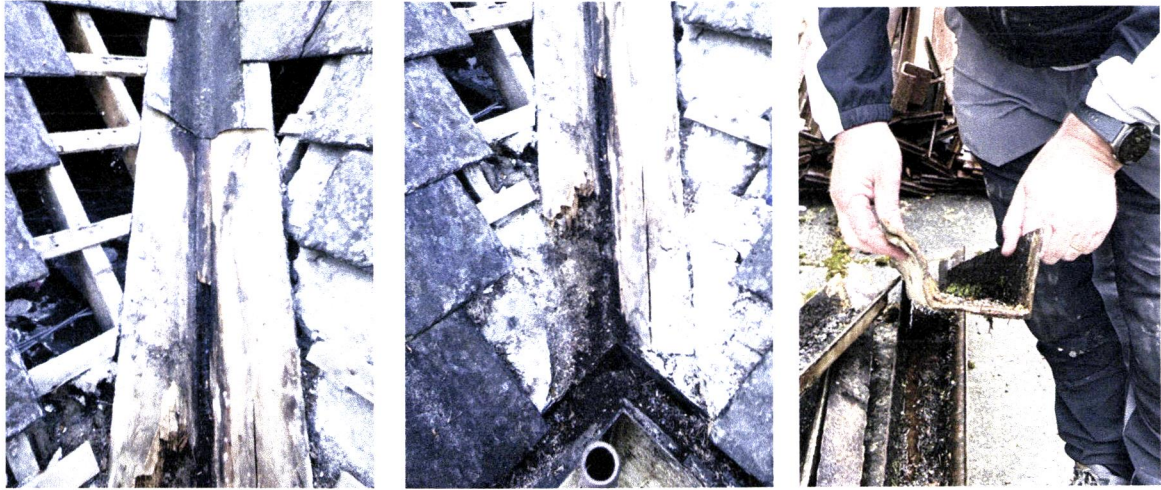
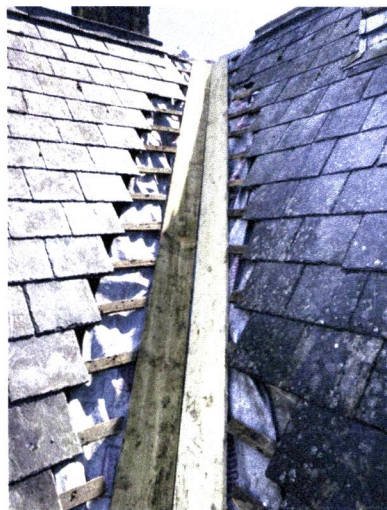
Valley over Dean's Room being repaired.

3.2.3 Lead valley has been repaired to halt deterioration of the building envelope and the wet rot infestation.

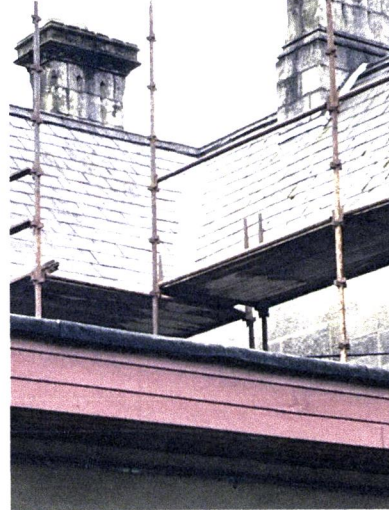
Valley repaired. Boards, lead and slate replaced.  
Cast iron rainwater gutter - profile special order.

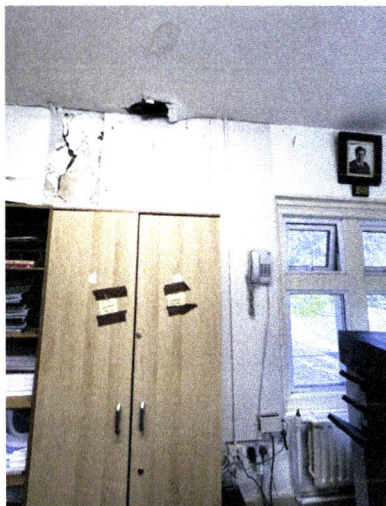
3.3.1 The Teacher's room, at first floor level in Kilcrone House, had a significant damp problem in one corner. This corner corresponds with the other side of the same wall in the Dean's Room.

Teacher's Room Water ingress from Valley over.

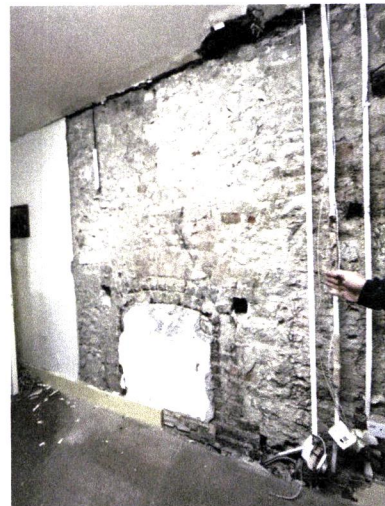
Teacher's Room - Walls treated.

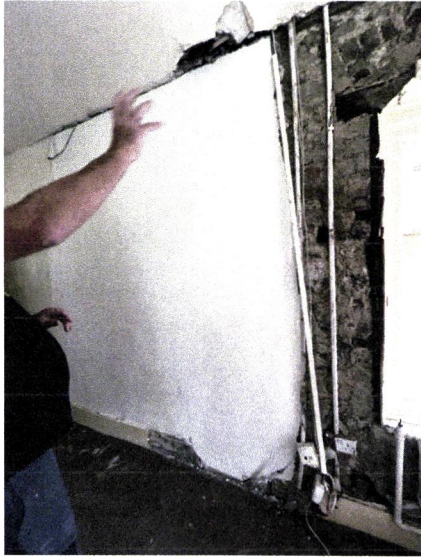
Teacher's Room - lime plaster partially reinstated. 20-06-2024  
(Window area requires more significant works - See item 3.3.5 below)

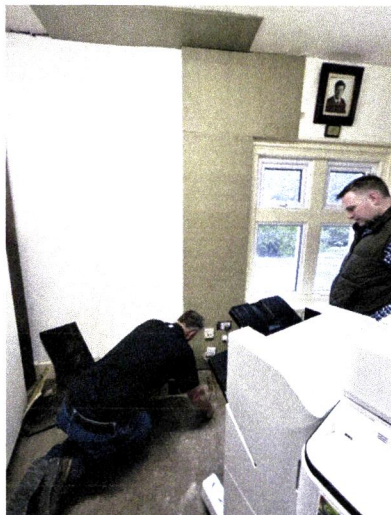
Teacher's Room - Wet Rot identified.

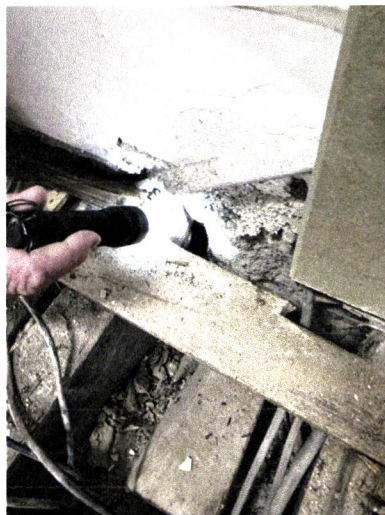
Floor joists under valley now repaired - rotten in wall  
Floor springy - localised rotten timbers.

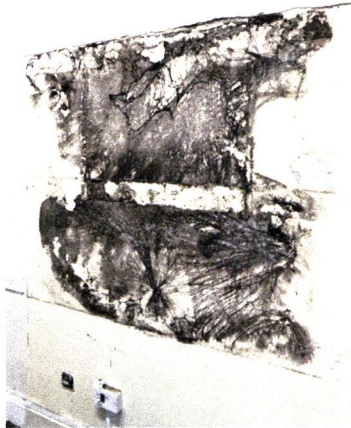
3.4.1 The Manager's room, at Ground floor level in Kilcronee House, had a significant damp problem on one wall. This corner corresponds with the wall and window in the Teacher's Room overhead.

Manager's Room - Wet Rot identified.  
Concealed window on rhs of Rot.

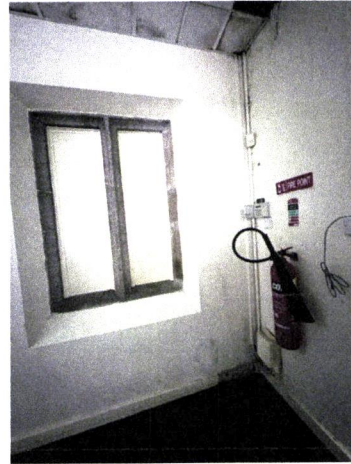
Other side of wall - concealed window.

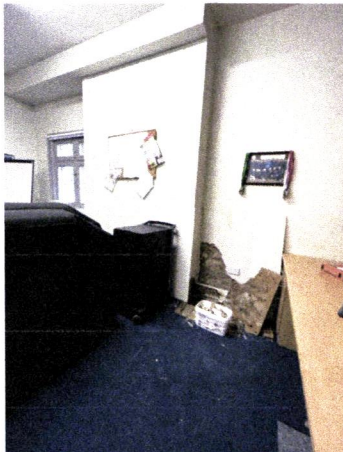
Manager's Room rhs chimney

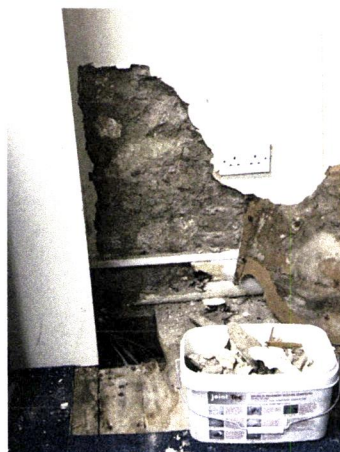
Opened-up floor joists rotten.

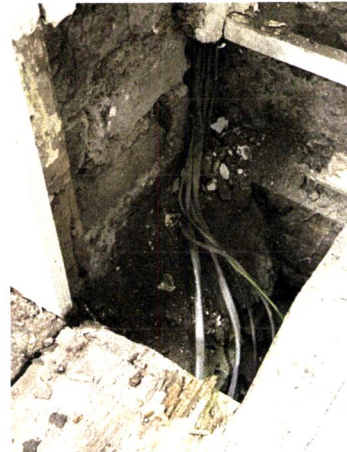
Damp from chimney and ground.

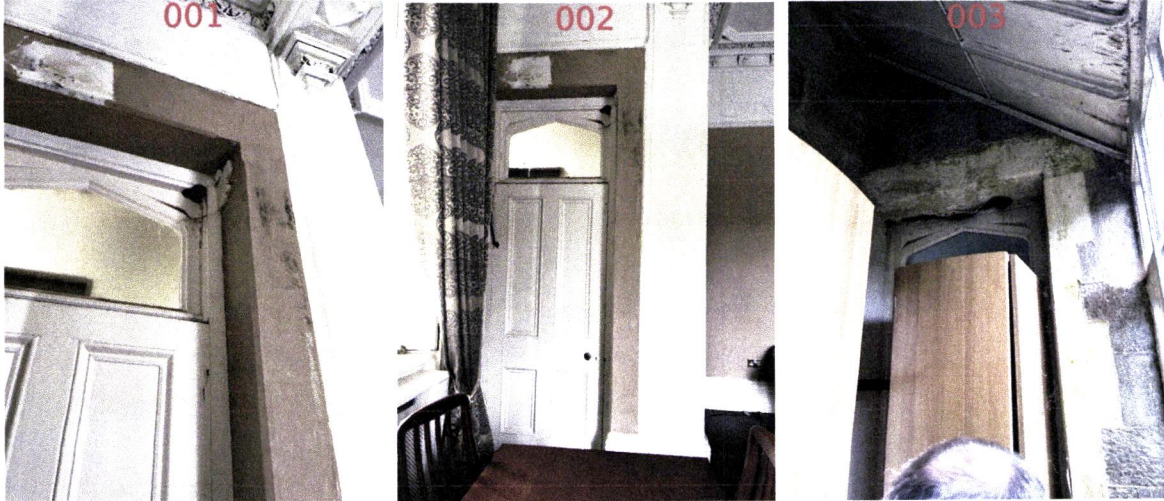
3.6.1 In March 2024, the fruiting body of *Serpula Lacrymans* was observed in the Lloyds Room. This indicates the presence of a Dry Rot infestation in Kilcronee House. Given the destruction caused by the same fungus in the Club Room Buildings, a decision was made to carry out emergency works to expose the extent of the fungus in the hope that it could be quantified, treated and contained quickly and effectively.

Bay window Dry Rot fruiting body in Lloyds Room. Fruiting body on both sides of bay window door.

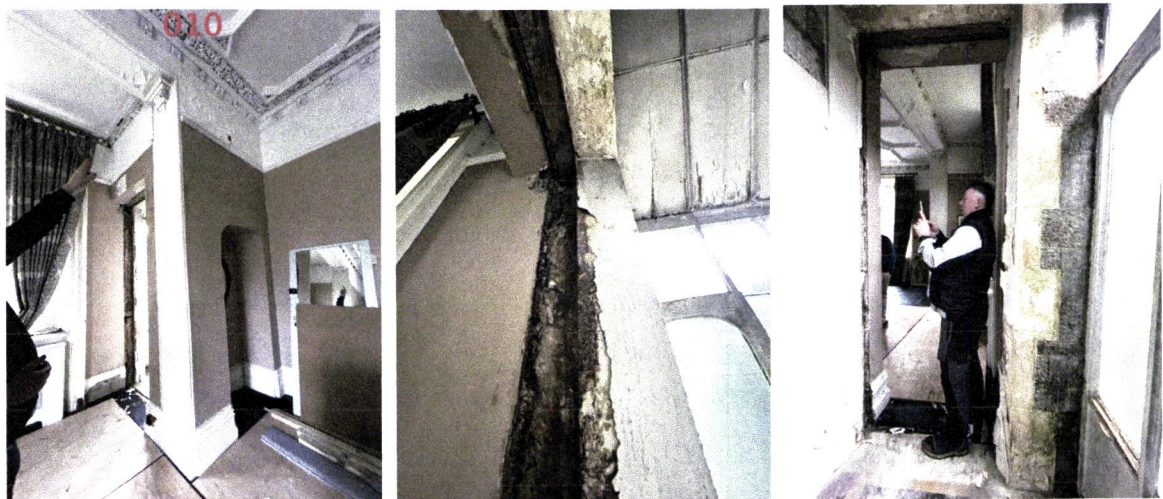
3.6.2 Site inspection and opening-up works around the bay window identified the likely source of the moisture feeding the infestation as a flat roof rainwater outlet that had failed and was allowing water penetrate the building fabric and flat roof over the bay window. A number of rainwater down pipes adjacent to the bay window were also identified as likely to be contributing to the ingress of moisture and resultant rot infestation.

Door Removed revealing dense Dry Rot infestation behind door frame.

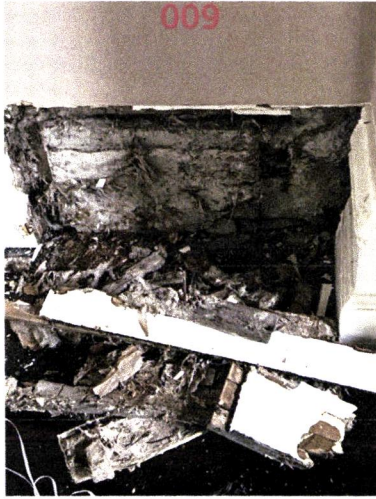
Skirting Board Dry Rot

3.6.3 Ceiling to bay window and lime plaster to be removed to investigate extent of Dry Rot. Skirting board on left hand side of fireplace near door into Lloyds Room was found to have dense Dry Rot infestation. Damp area in corner of Lloyd Room to left hand side of window to front elevation suspected of having fungal infestation. Emergency works to open-up these three areas were carried out. Prior to the removal of lime plaster, cornices, cornice enrichments, papier mache freeze and timber mouldings. The Old Mould Company and David Broderick have taken measurements, samples and rubber moulds so that the bay window can be accurately restored after eradication of Dry Rot.

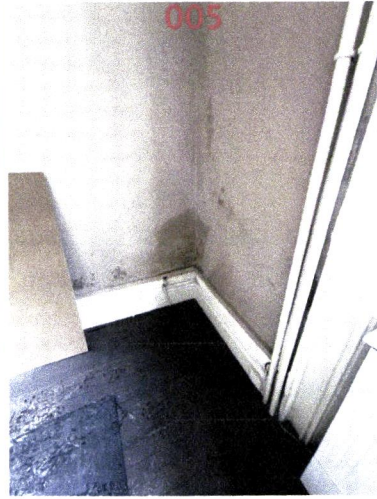
Damp corner of Room.

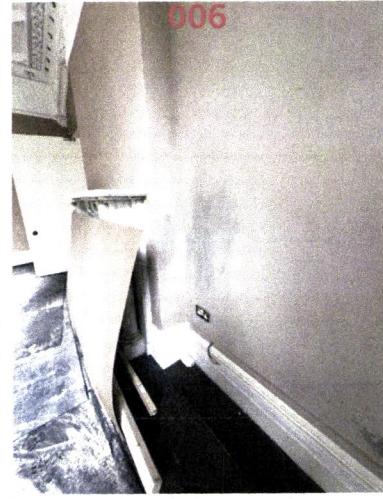
Damp at rhs of Chimney breast.

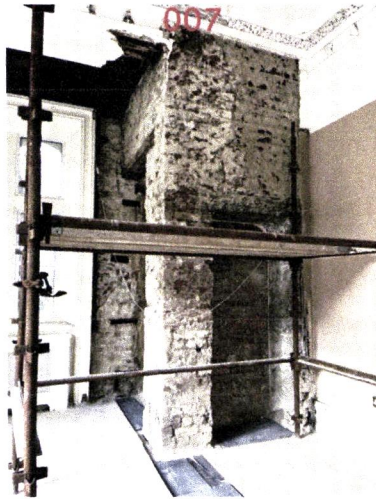
Bay Window Dry Rot exposed

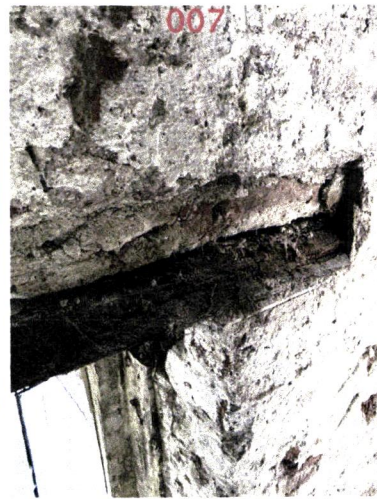
Head over door Dry Rot

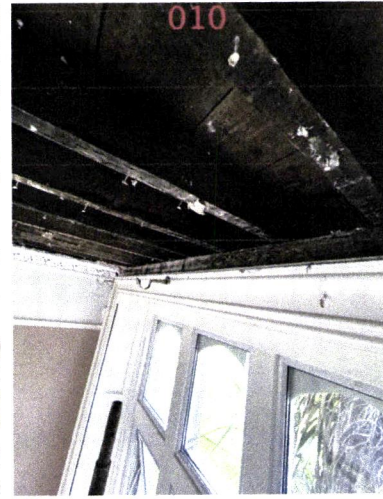
Bay window flat roof joists rotten.

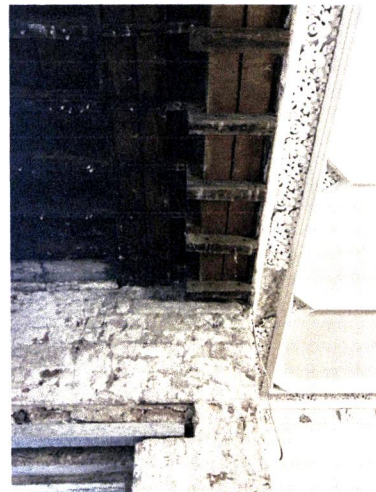
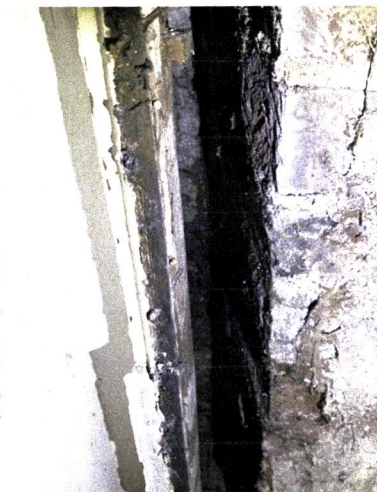
Bay Window Timber beams bearing ends to be checked for rot.

Dry Rot observed deep in rhs bay window between timber frame and masonry opening. Bay window will need to be removed to treat.
