RE: Declaration in accordance with Section 5 of the Planning & Development Acts 2000 (As Amended) – EX69/2024 – Legionaries of Christ, Dublin Oak Academy, Bray

DECLARATION IN ACCORDANCE WITH ARTICLE 5 (2) (A) OF THE PLANNING & DEVELOPMENT ACT 2000 AS AMENDED

The Section 5 application seeks a declaration as to whether the Emergency Repairs and Renewals to Club Room Building at Kilcronee House are development and are exempted development.

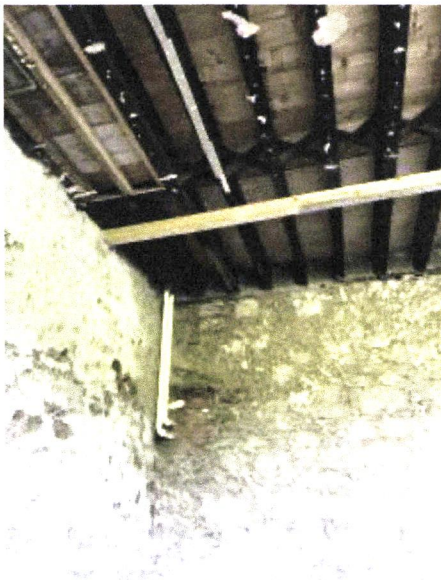
Replacement of Floor joists in area of recorded dry rot. To avoid damage to the walls a like for like joist will be positioned following treatment into the existing seating pocket.

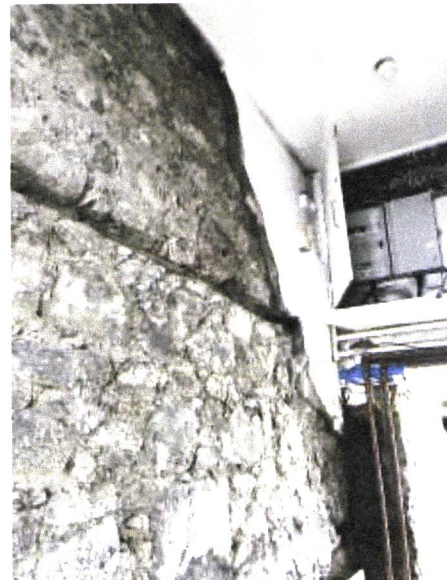
Replacement of decayed build in timber with selected Engineering brick and lime mortar.

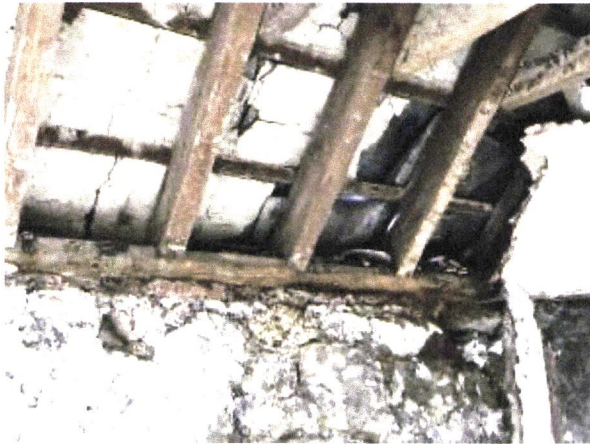
Replacement wall plates in accordance with timber conservation specialists report

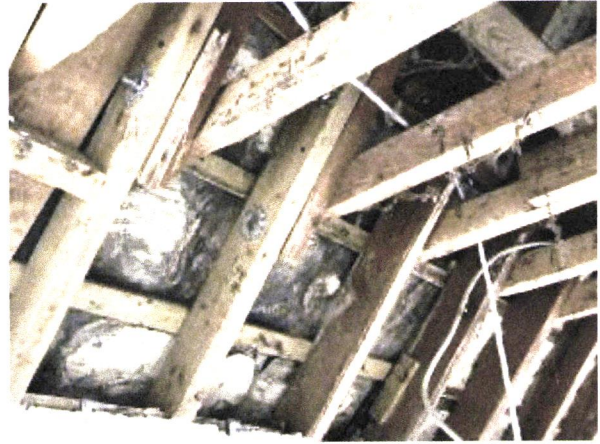
Remediate previous splicing which was found to be sub-standard. Install new sister rafters and splice with M10 coach bolts with shear connectors.

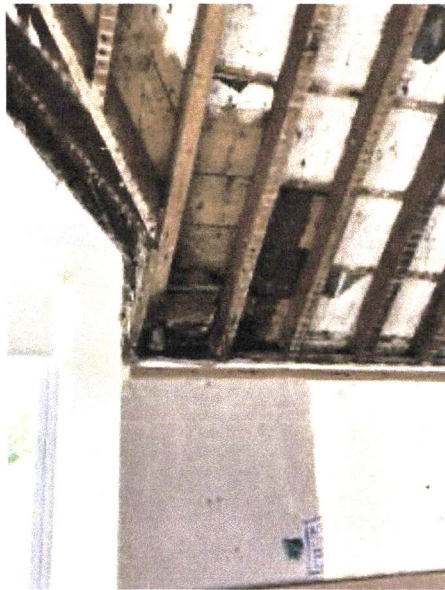
Cut back and treat decayed timber rafters in accordance with timber specialists report. Install treated new sister rafter and splice to existing with M10 staggered coach bolts with shear connectors.

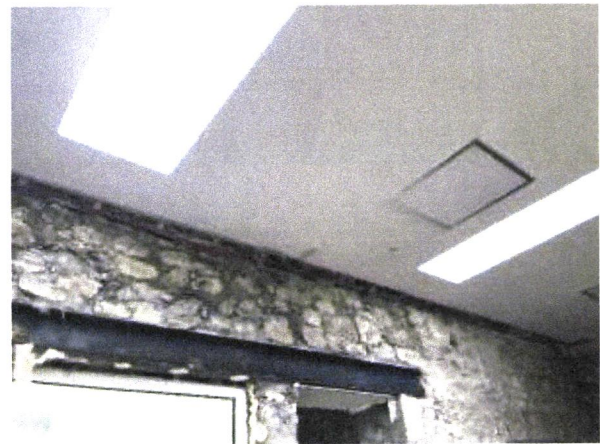
Treat existing steelwork with corrosion protection.

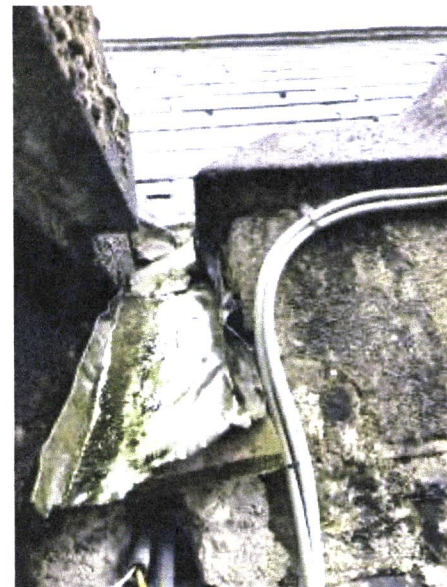
Replace defective and non-conforming gutter detail.

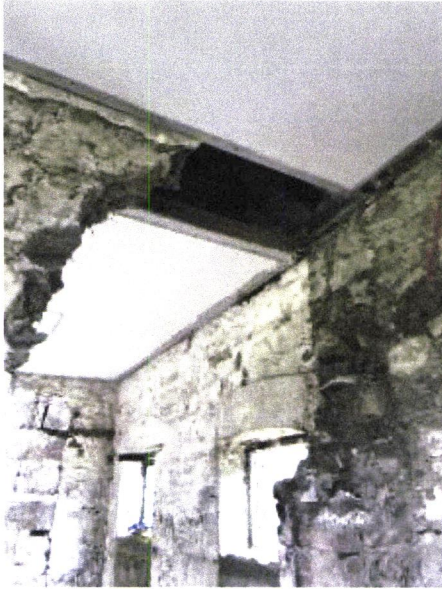
Install replacement head with PC lintel and reconstruct masonry wall over.

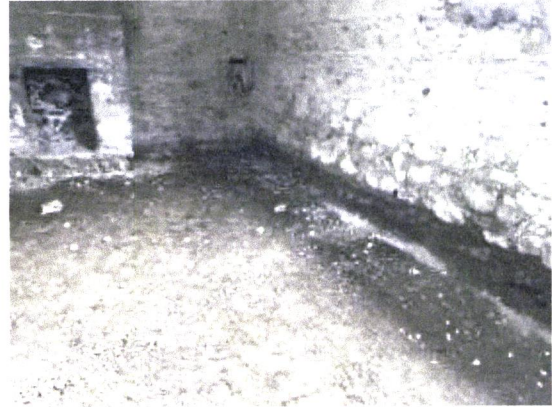
Replacement ground floor with a new insulated sla

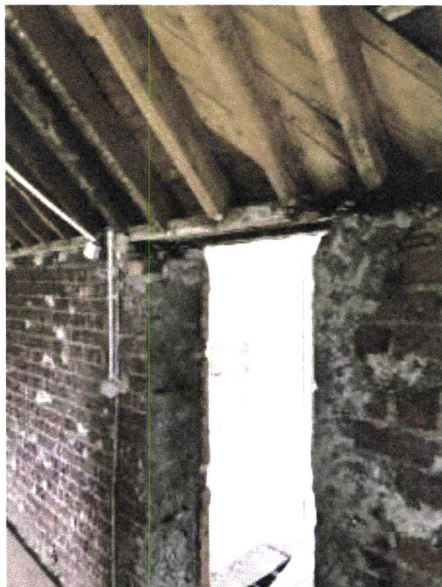
Replace existing door heads with hardwood timber lintel reinforced with primed 100x100 equal angle beam.

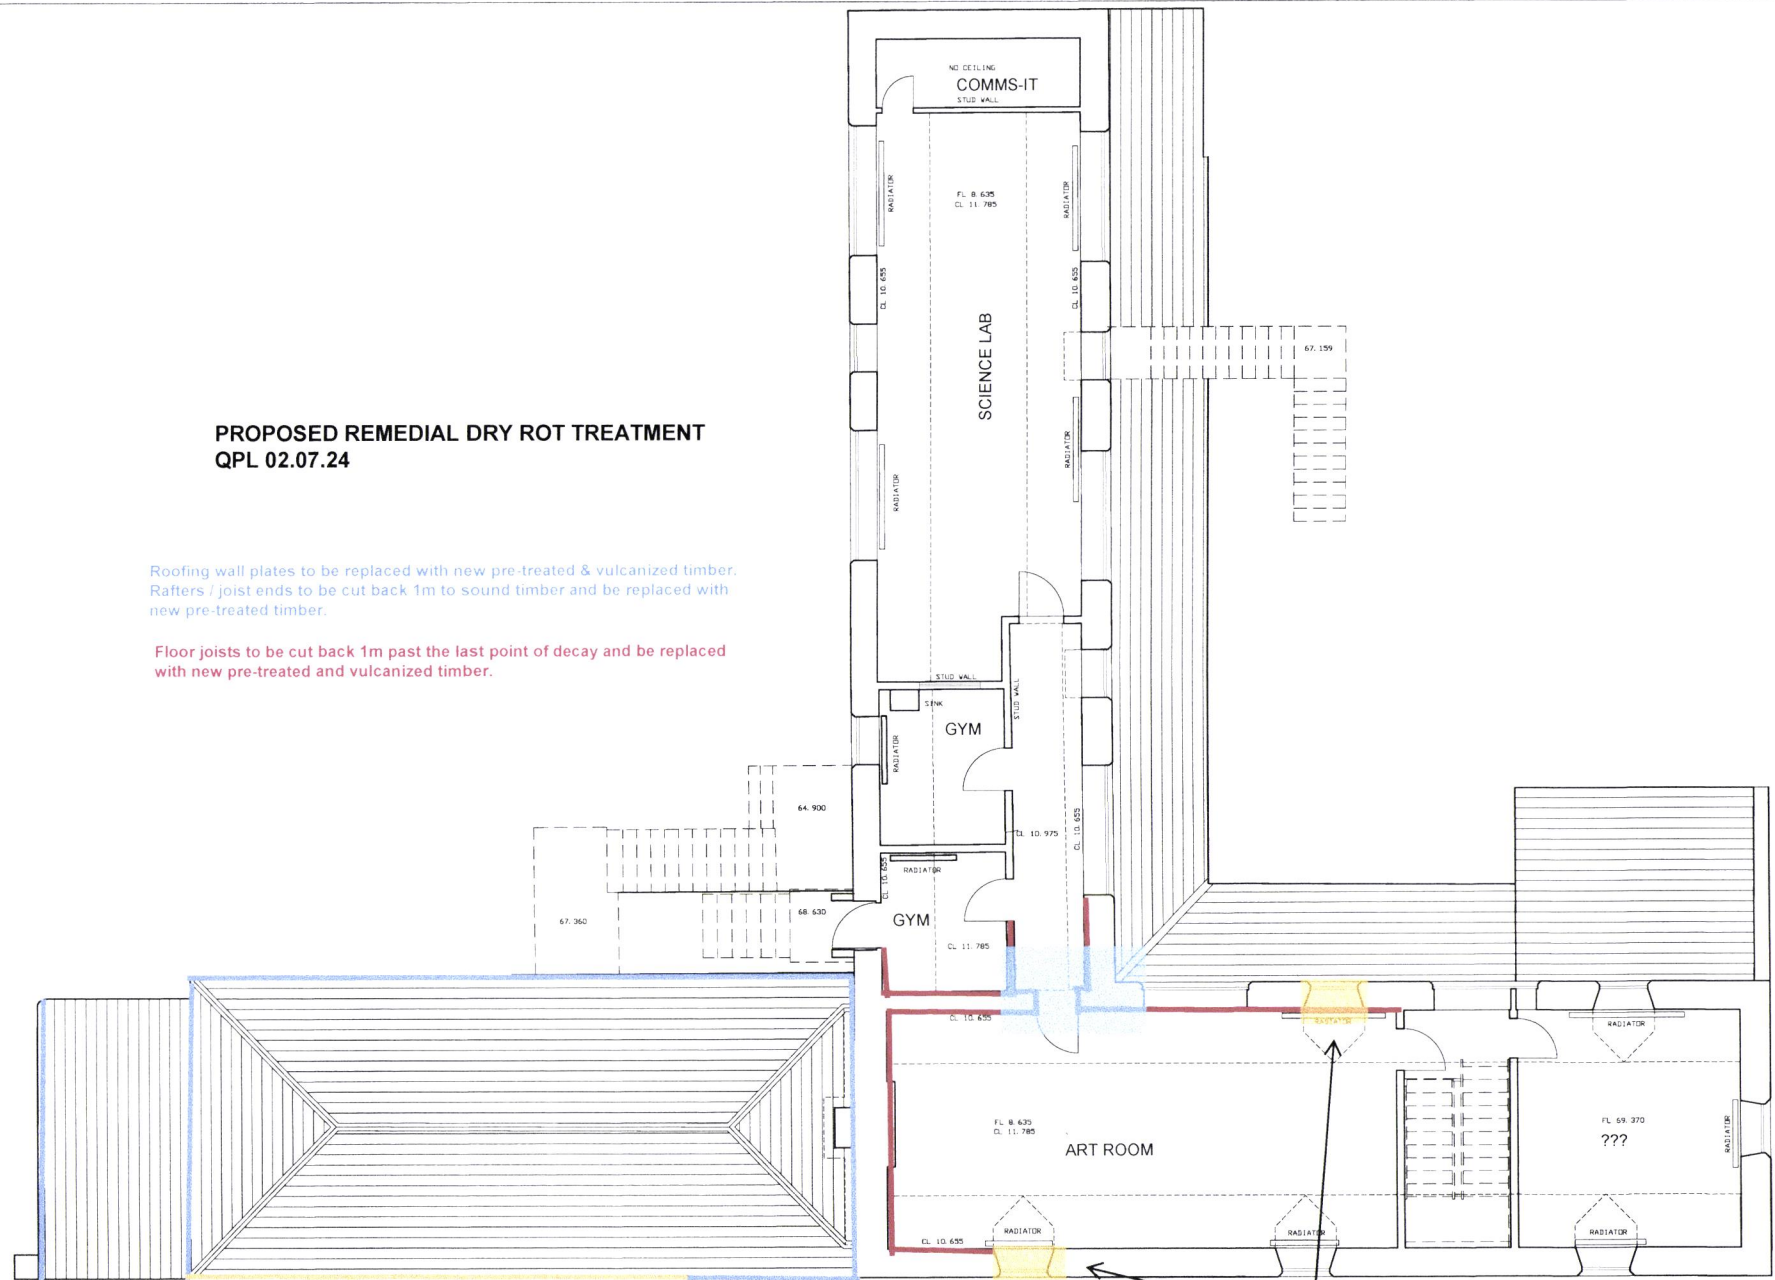
↑
**Expose section of roofing wall plate
for closer examination**

↑
Lintels to be drilled & tested / treated

Roofing wall plates to be replaced with new pre-treated & vulcanized timber.
Rafters / joist ends to be cut back 1m to sound timber and be replaced with new pre-treated timber.

Floor joists to be cut back 1m past the last point of decay and be replaced with new pre-treated and vulcanized timber.

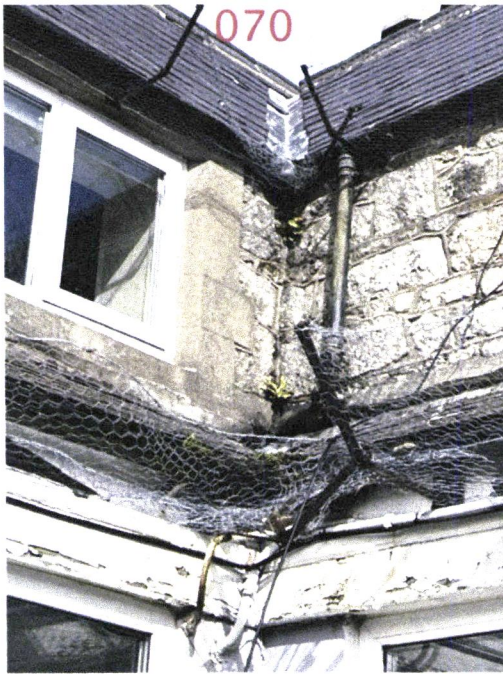
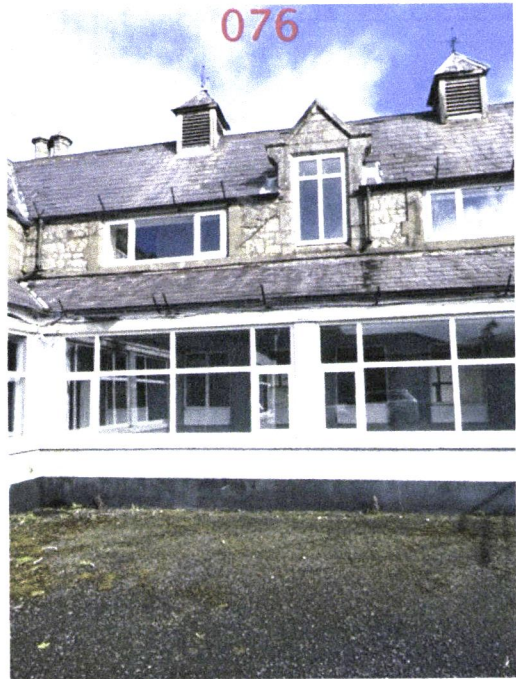
Roofs to Club Room Buildings - Leaking valley

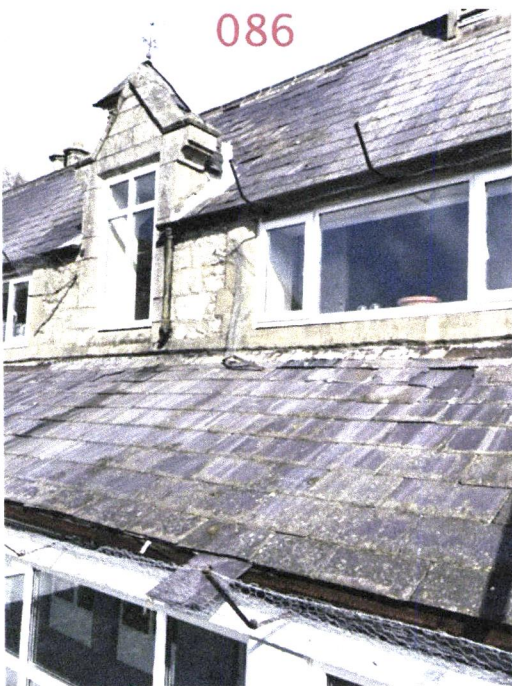
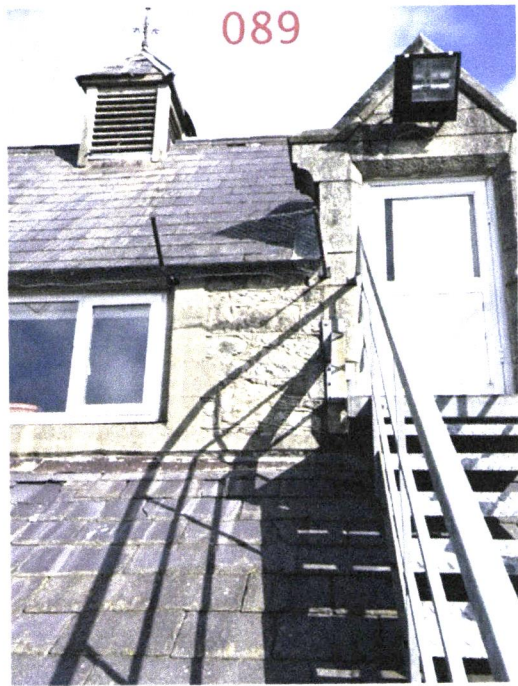
Roofs to Club Room Buildings - Cupolas in a state of total disrepair.

3.2.2 Scaffolding will be erected to allow a thorough examination of the roof at close quarters. The roof will be carefully inspected 5m section-by-section process. We expect most of the nails holding the slates will have rusted. However, we anticipate retaining between 50-75% of the original roof slates and will replace broken or delaminated slates with a similar colour and approved natural slate of the same size and gauge. The majority of lead valleys at the dormers and to roof valleys will need replacement. The lead is old and has stretched and become brittle and is leaking in several areas.

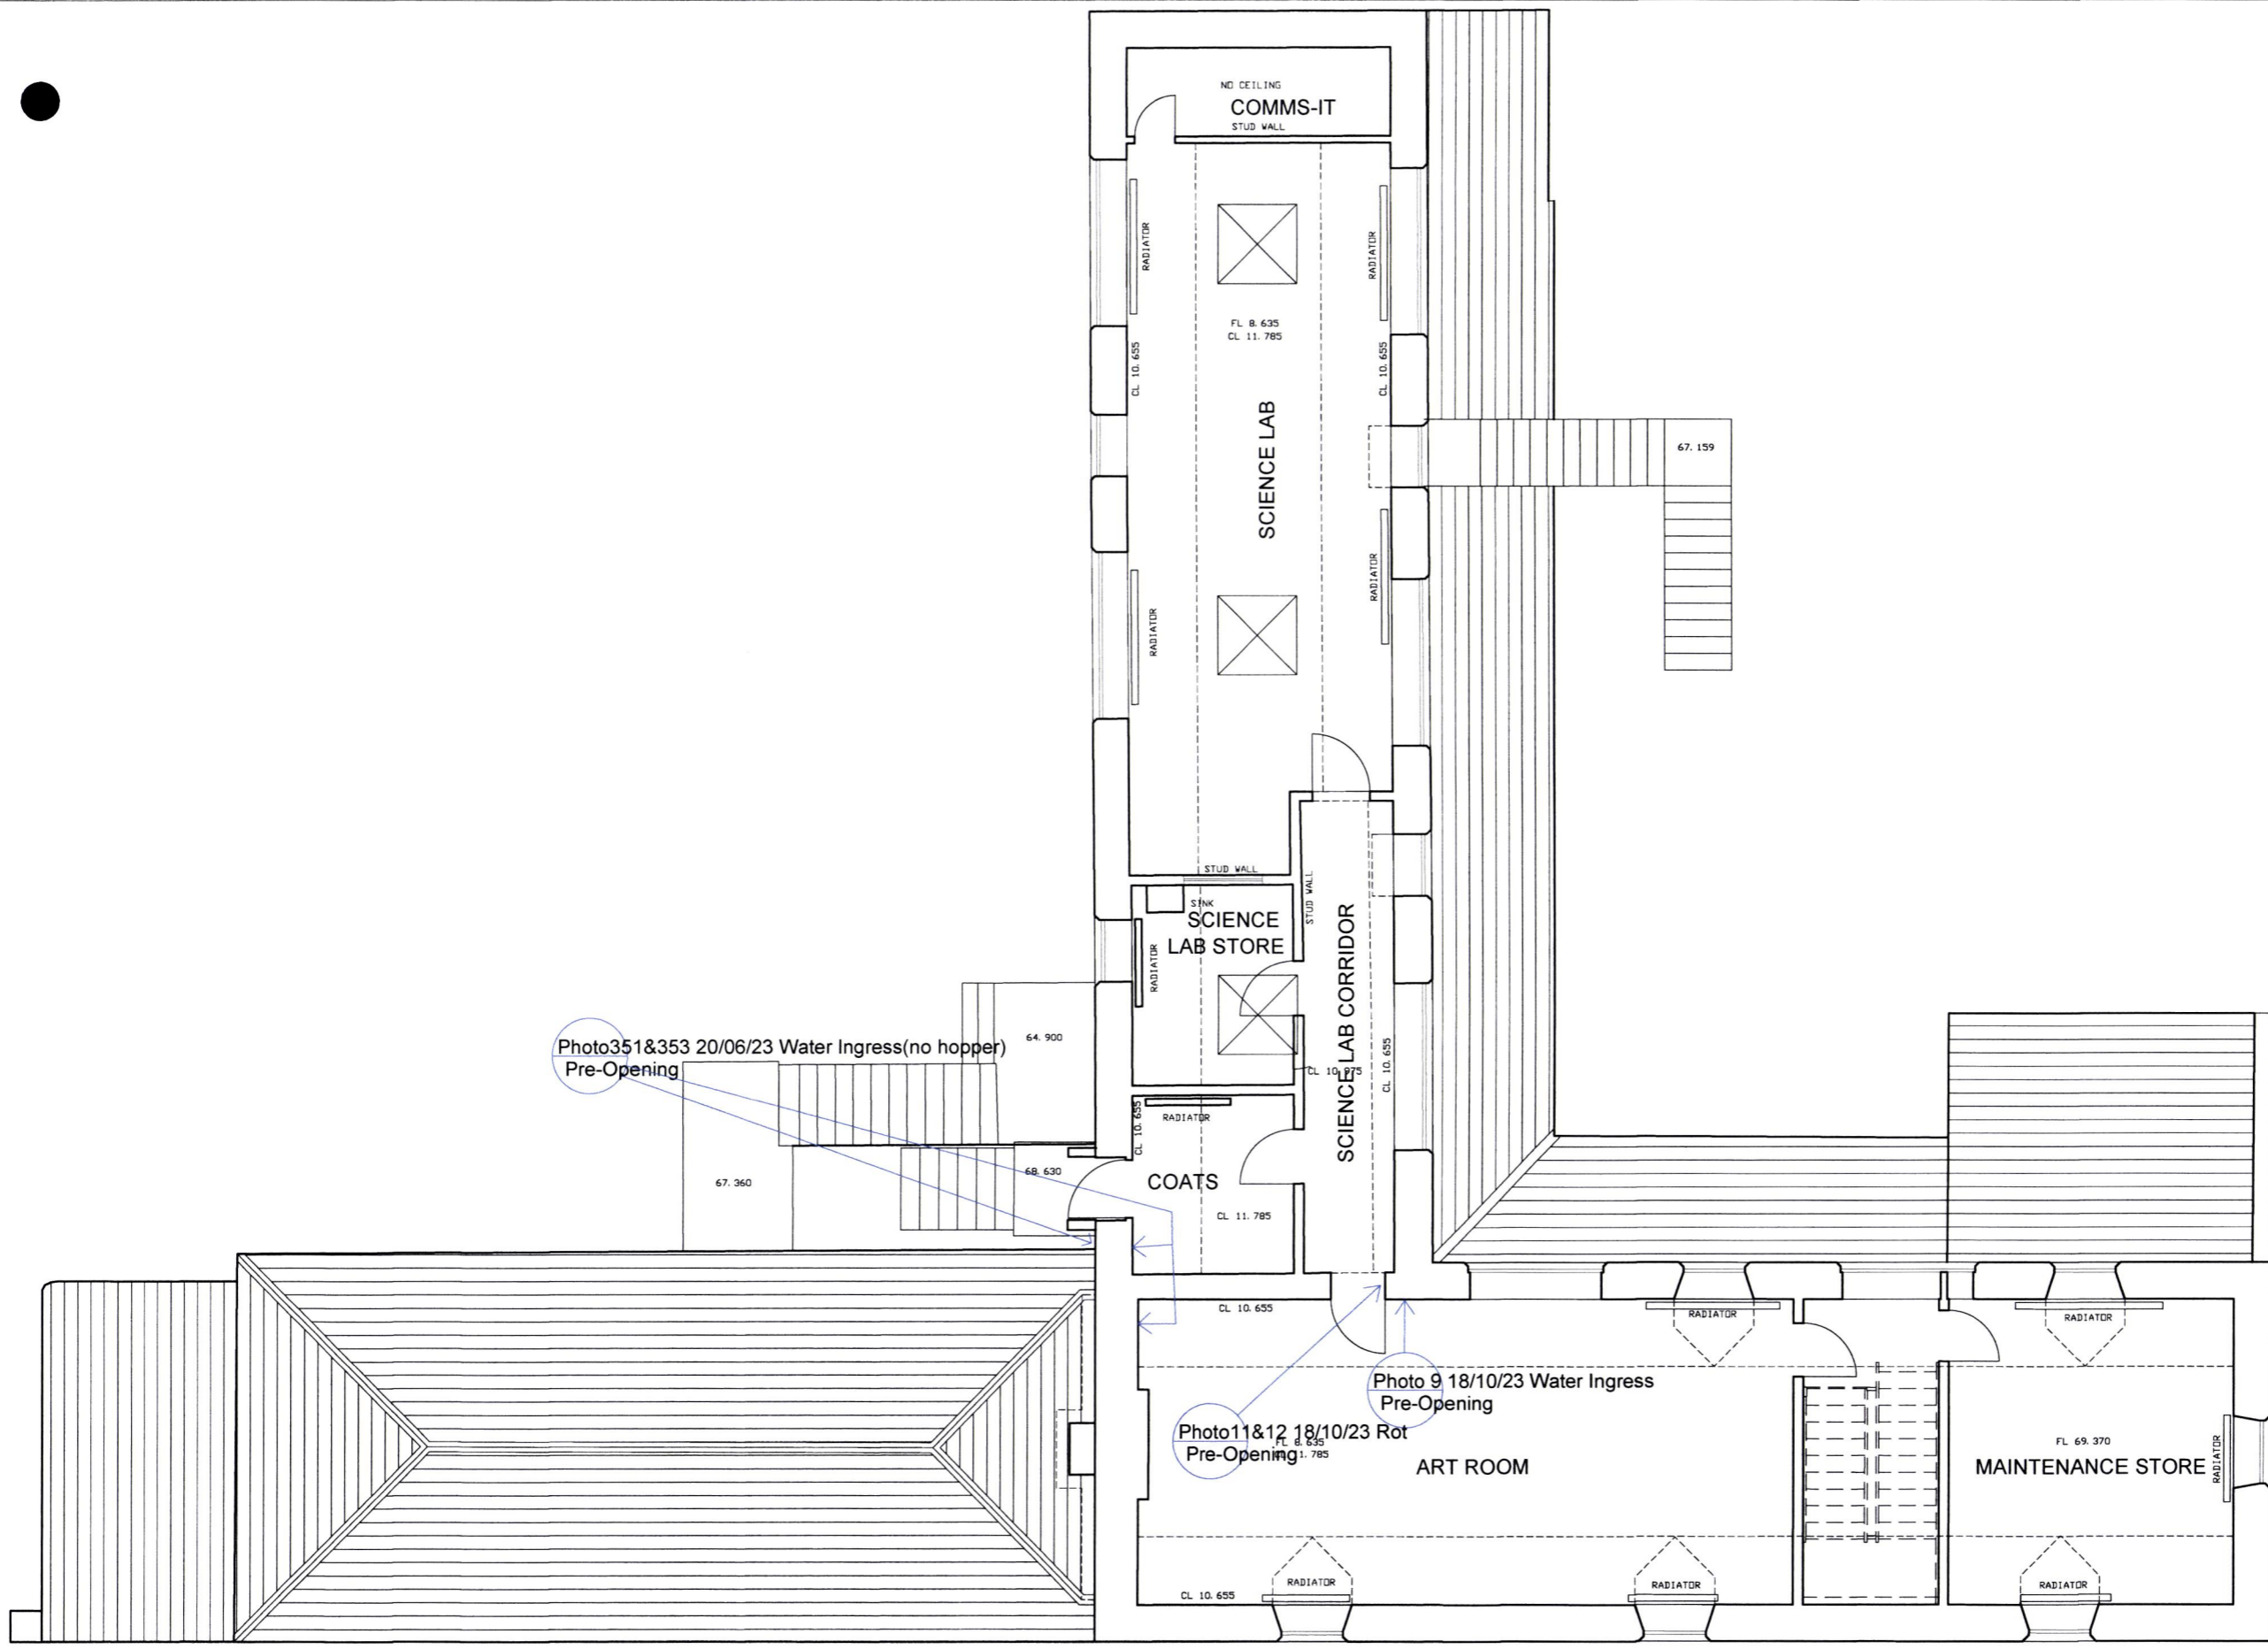
Photo 351 & 353 20/06/23 Water Ingress (no hopper) Pre-Opening

Photo 9 18/10/23 Water Ingress Pre-Opening

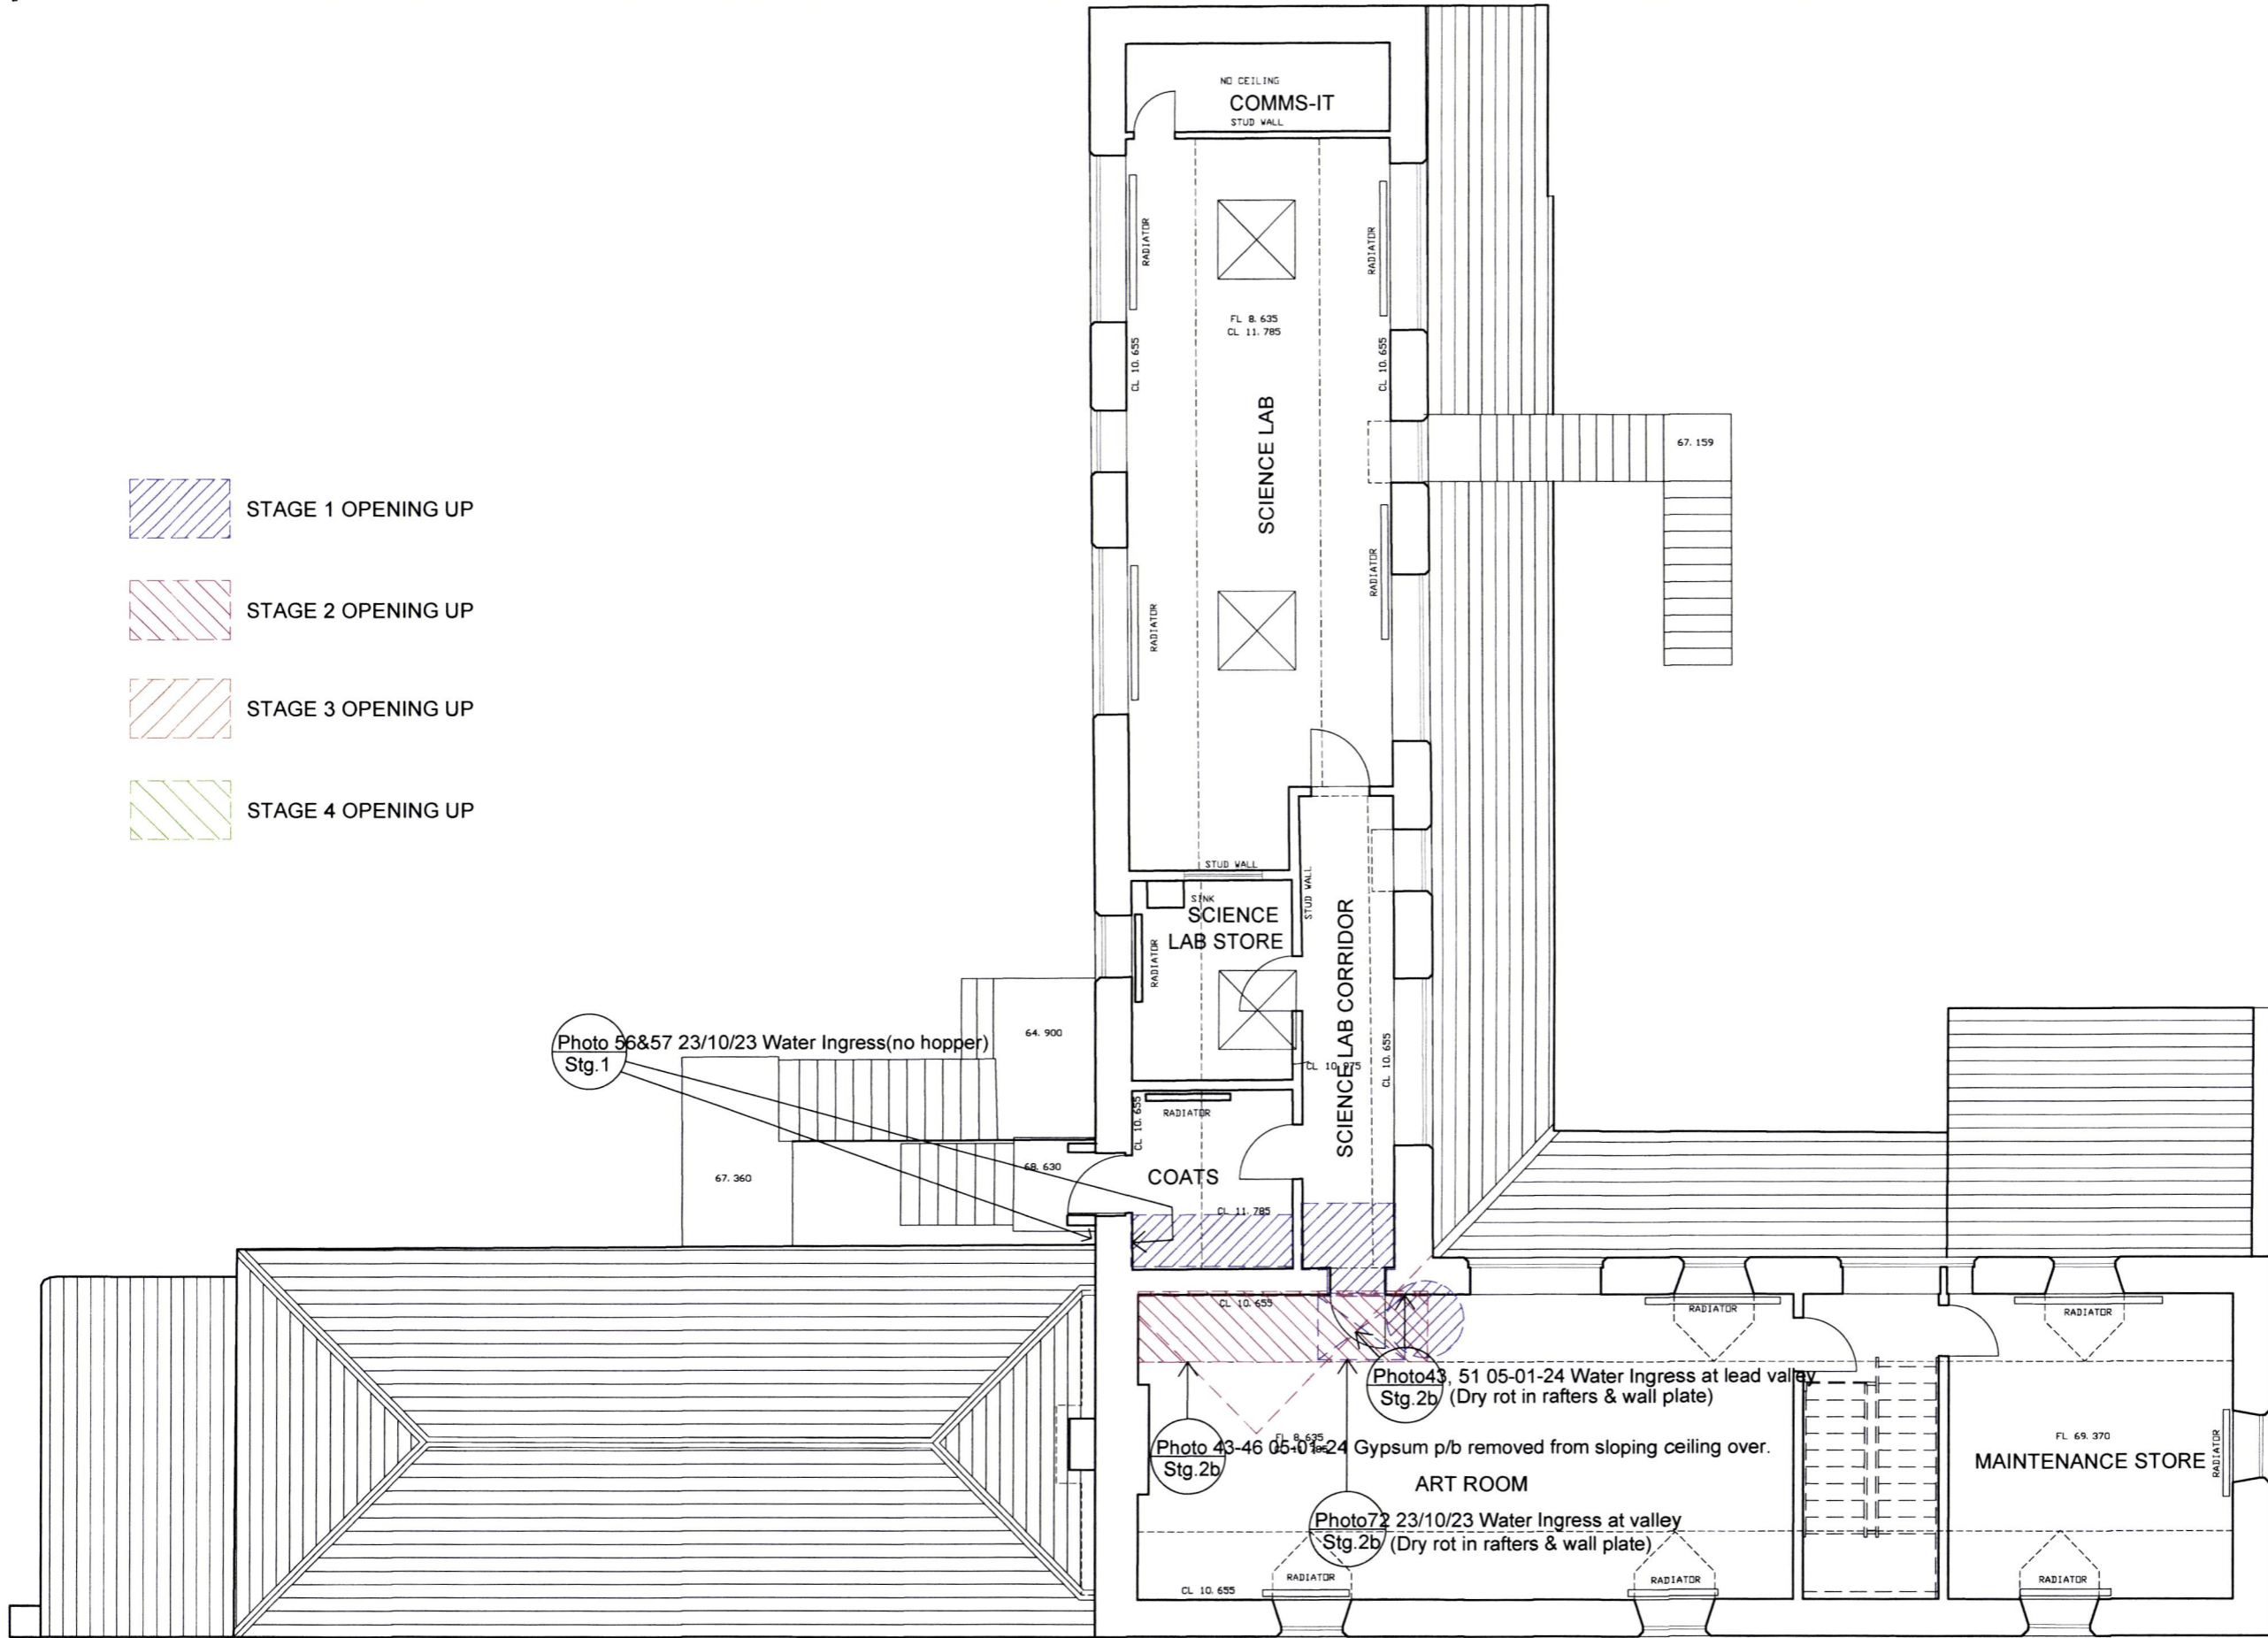
Photo 56&57 23/10/23 Water Ingress (no hopper)
Stg.1

Photo 43-46 05-01-24 Gypsum p/b removed from sloping ceiling over.
Stg.2b

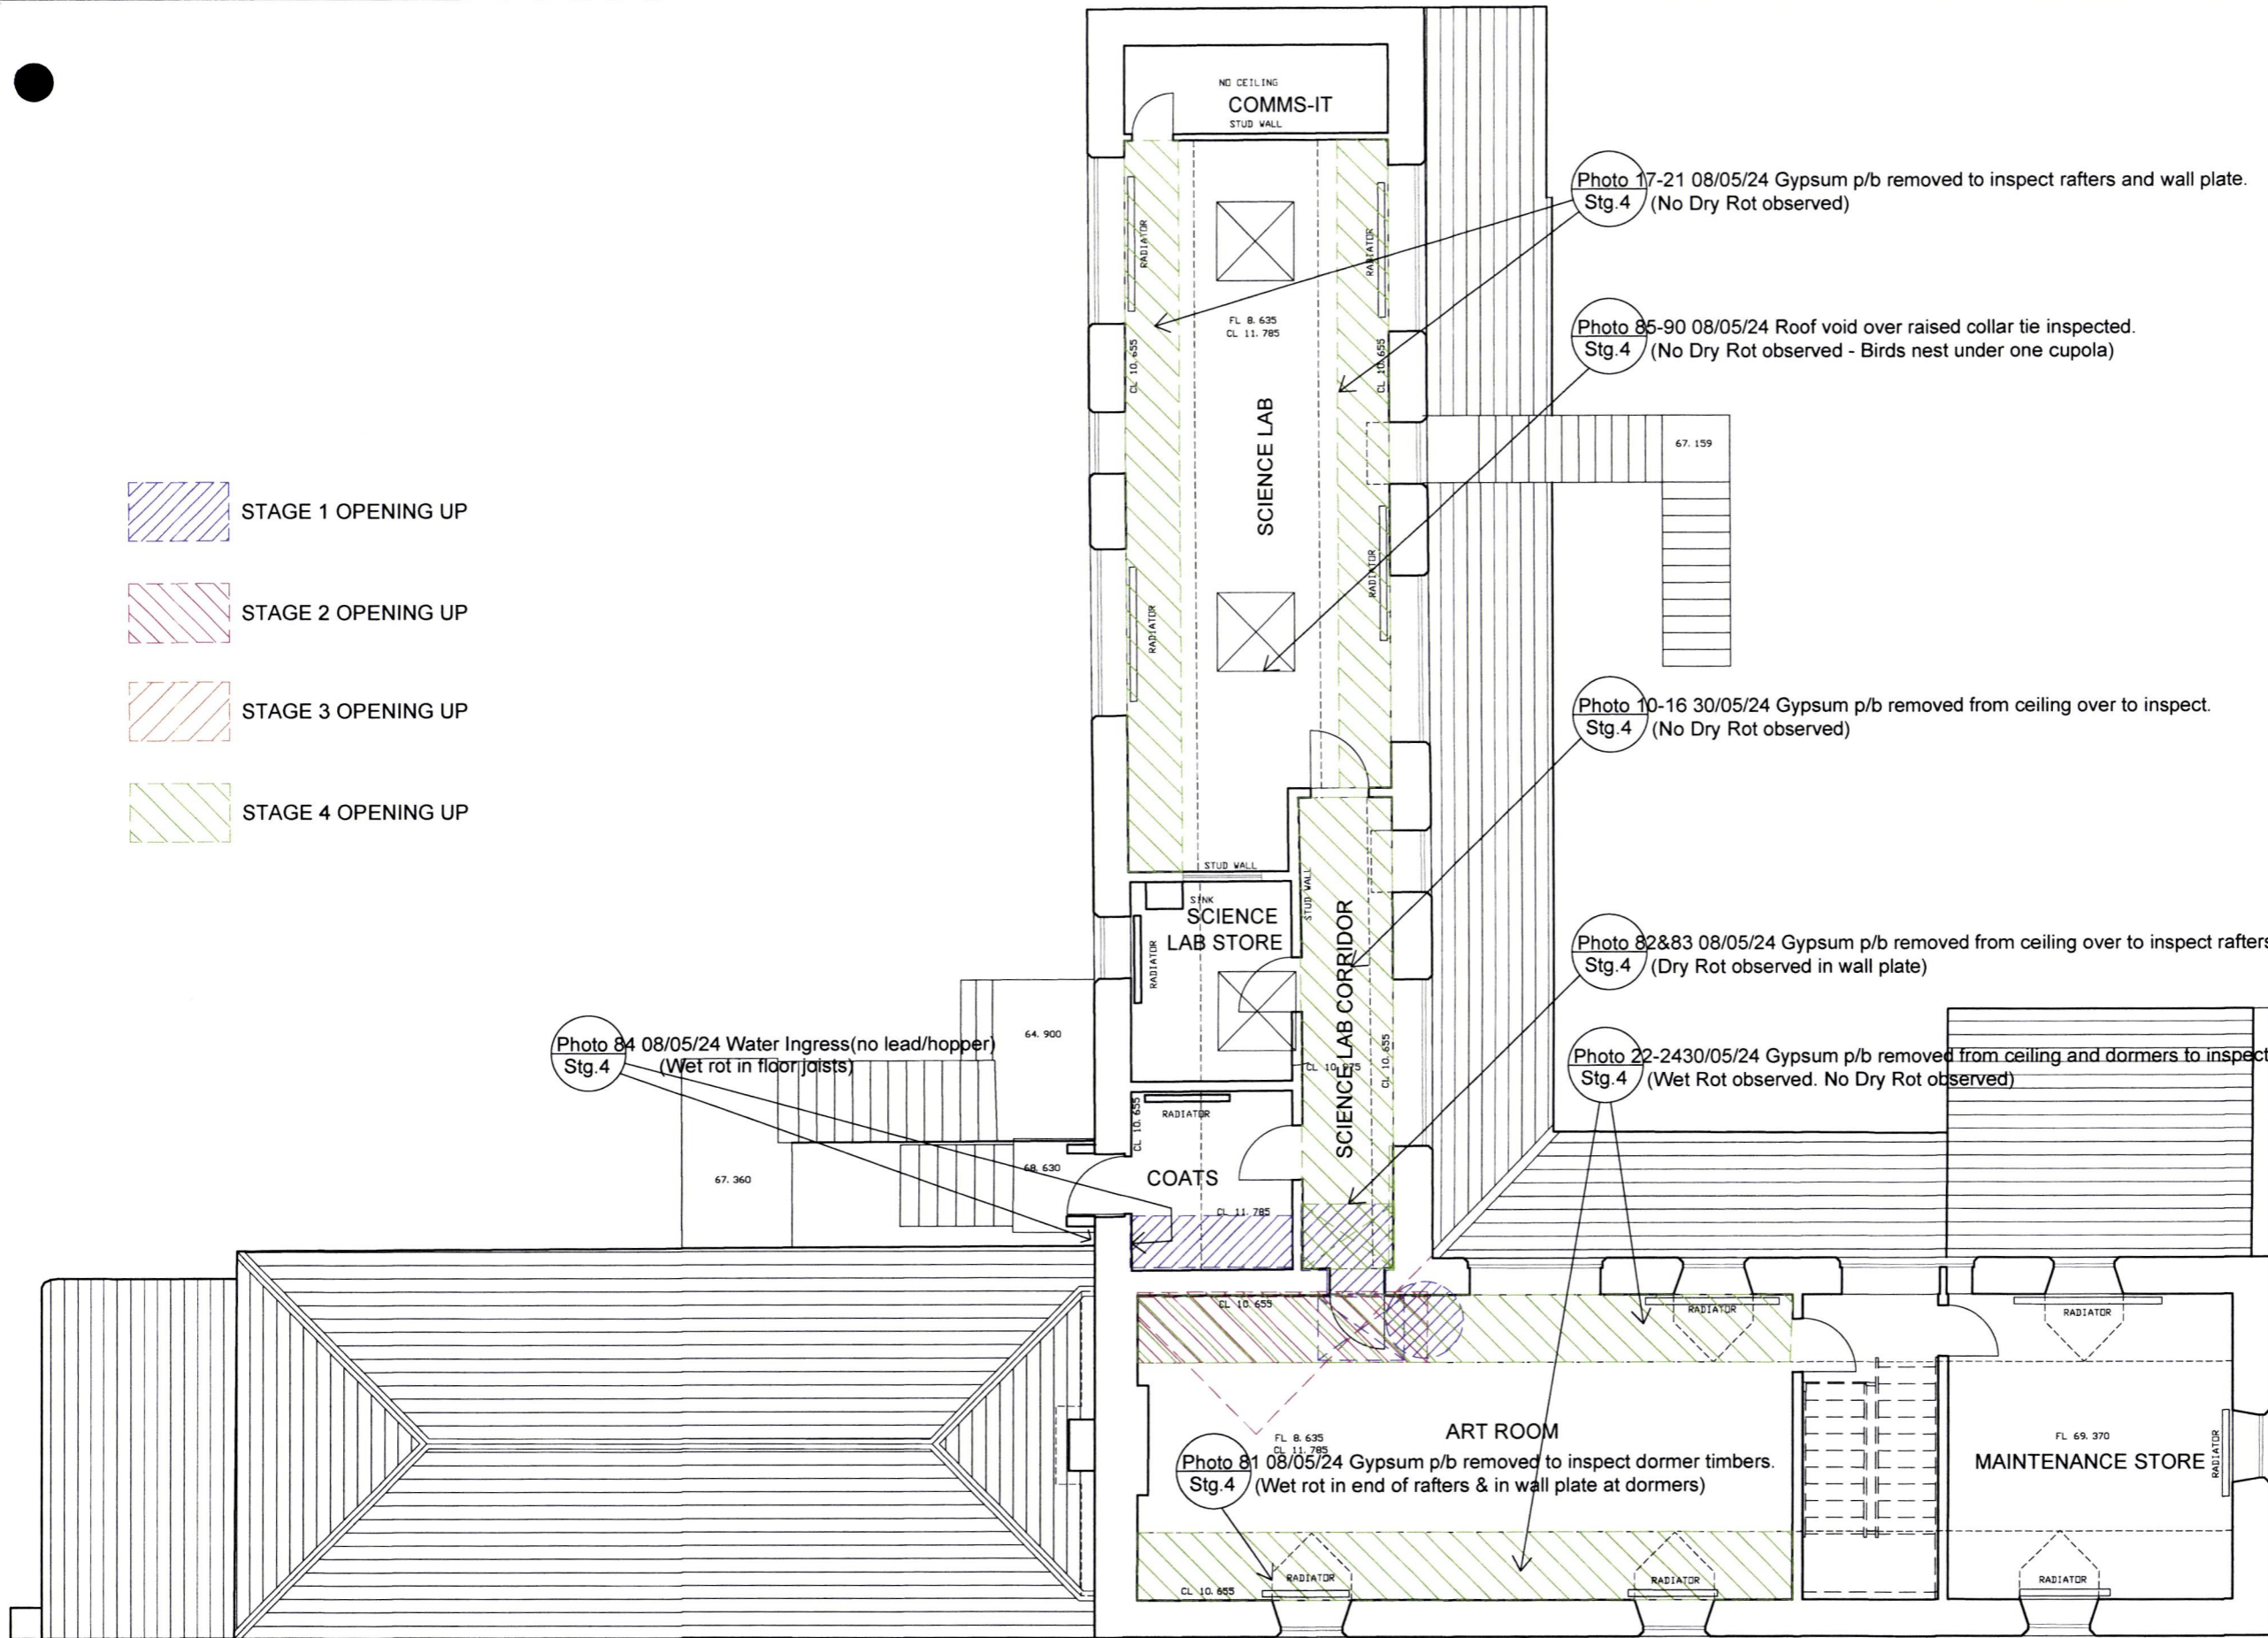
Photo 84 08/05/24 Water Ingress (no lead/hopper)
Stg.4 (Wet rot in floor joists)

Photo 17-21 08/05/24 Gypsum p/b removed to inspect rafters and wall plate.
Stg.4 (No Dry Rot observed)
