Blessington eGreenway

Archaeological Impact Assessment

Wicklow County Council

Project number: PR-447455

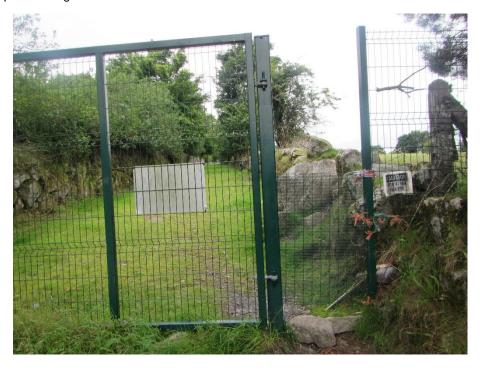
As such, access was not possible to some of the locations of the recorded archaeological sites such as the moated site (WI005-078) at Carrig. Similarly, the lane between Valleymount and the shore was formerly part of the Bog Road which linked Valleymount to Ballyknockan to the east but is now mostly under the reservoir. This lane has been gated off at both ends at some time after the 2015 site visit with the result that the cross-inscribed stone (WI010-048) is visible but not accessible (Photograph 1). It is the large sub-rectangular stone directly behind the sealed pedestrian gate.

Photograph 1 Gated lane with the cross-inscribed stone (WI010-048)

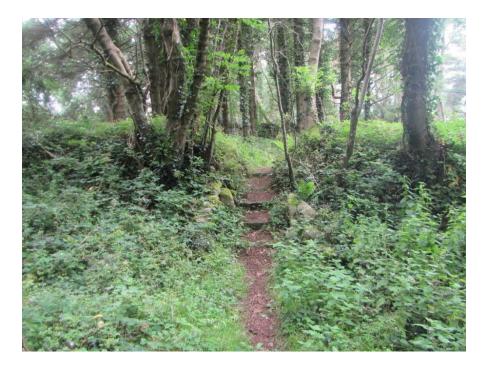
Features of note within the forestry include former landscape features consisting of a path and steps flanked by low stone walls (Photograph 2). These appear to predate the creation of the reservoir. A more recent feature is a plaque attached to a tree which forms a memorial to Rachel Amy Doran who died in February 2018 (Photograph 3).

Photograph 2 Valleymount section of path, steps and walls in forestry

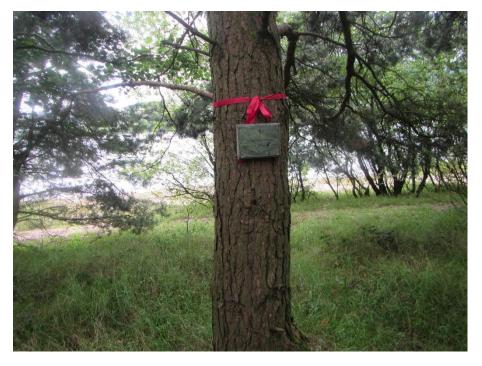
Photograph 3 Valleymount memorial erected post February 2018

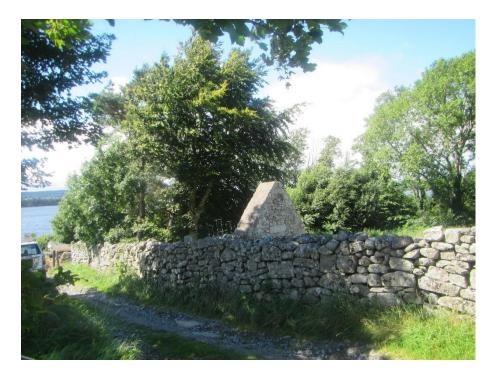
The protected structure known as 'Biddy Mulvey's Cottage' (RPS 10-5) is located at the end of a lane known locally as 'the Bog Road' that leads to the shore from Ballyknockan and originally formed a link to Valleymount (Photograph 4).

Photograph 4 Ballyknockan protected structure known as' Biddy Mulvey's Cottage' (RPS ref 10-5) and the Bog Road

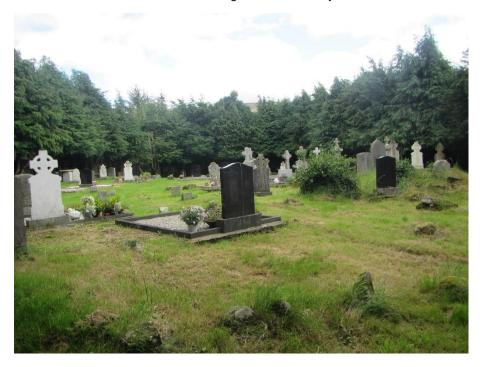
From Ballystockan continuing north along the edge of the lake the proposed route bypasses 80m to the south of Templeboodin consisting of five recorded monuments classified as a church, ecclesiastical enclosure, graveyard, bullaun stone and grave slab (WI010-011001-011005) (Photograph 5). Along the shoreline this section of the lake has seen considerable erosion with rock armouring added for stability.

Photograph 5 Graveyard at Templeboodin

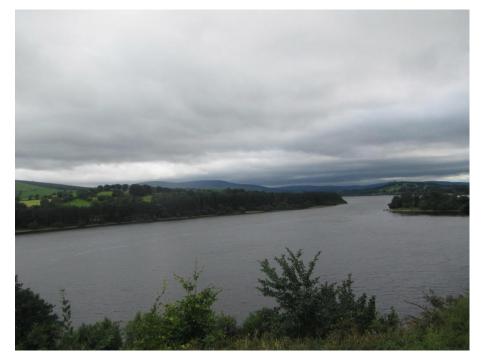
To the north in Burgage More a Mill site (WI005-121) was partially exposed when the lake levels dropped in January 2006. The site has since been submerged again and there are no visible traces. Further to the north the route passes through the western portion of Knockieran Cottage Demesne (NIAH ref 4266). Much of this planned landscape has been permanently flooded by the reservoir and what remains is unrecognisable (Photograph 6).

Photograph 6 Shoreline where Knockieran Cottage Demesne (NIAH ref 4266) is located

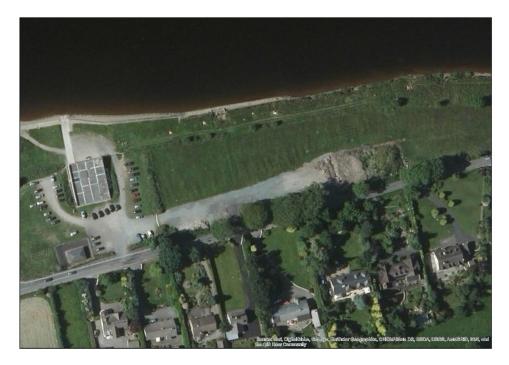
The Lacken section of the scheme finishes at Blessington Bridge (NIAH 16303027) with an underpass planned through the south embankment allowing access to Knockieran car park (Photograph 7). The existing car park is used by the public to access the shoreline and also by numerous groups who utilise the reservoir for leisure purposes such as rowing. This car park will be refurbished and also extended to incorporate 50 new car parking spaces. The area of the extension incorporates parts of the existing car park including gravel surfaces as well as adjacent grassed areas. Tree planting is also intended within the eastern extent of this area.

Photograph 7 Overview of the Proposed location of the extension to Knockieran Car Park.

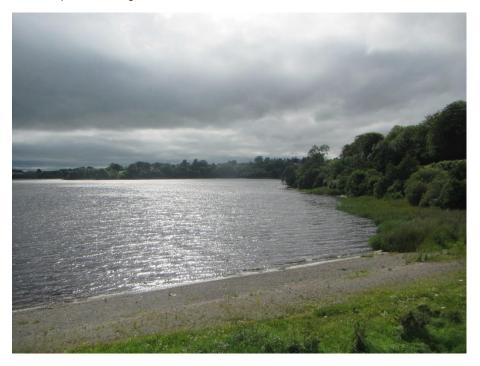
Blessington Bridge (NIAH 16303027) carries the road over the reservoir to the Kilbride Road which leads into Blessington. The trail turns south to run along the west side of the reservoir through the terrain between the Kilbride Road and the reservoir (Photograph 8). This terrain slopes steeply down from the road to the water requiring retaining structures to be constructed to support the path. The location of the Holy Well (WI005-026) is adjacent of this section of the path submerged in the reservoir.

Photograph 8 Looking southwest along shoreline leading towards Blessington.

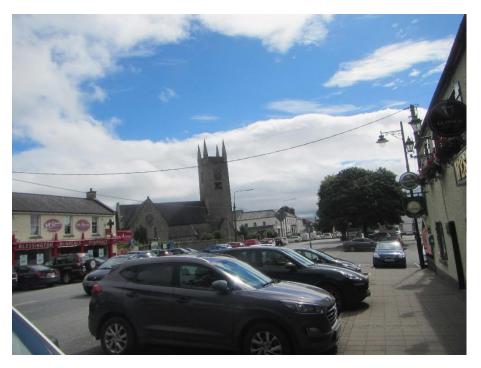
The scheme extends to the northwest linking into the existing road network and passing through Blessington. The town centre of Blessington has been proposed as an Architectural Conservation Area, and contains numerous structures listed on the RPS and NIAH assets on the main street (Photograph 9). The scheme continues southwest along the existing roads before reaching The Avon leisure and holiday accommodation complex.

Photograph 9 Proposed Blessington Architectural Conservation Area

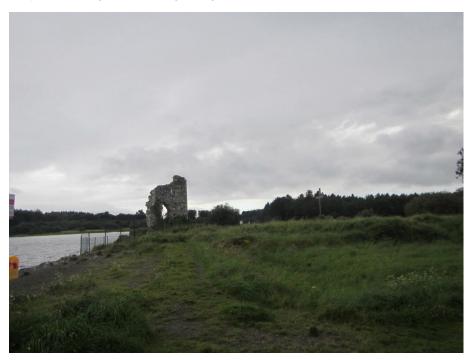
The existing Blessington Greenway commences at The Avon leisure and holiday accommodation complex extending south through Burgage More. The Greenway extends south before passing to the northwest of the medieval settlement at Burgage More (W1005-070). This site was excavated before the reservoir was created with the graves slabs and high crosses removed. The ruins of the tower house (RPS ref 05-09) are still apparent and the former location of the High cross (WI005-070007), which is now in Blessington graveyard, has had its location marked with a wooden cross (Photograph 10). The Greenway passes to the north of the archaeological sites and no works will take place adjacent to it. Archaeological monitoring works were conducted during the construction of the Greenway with nothing of archaeological significance uncovered.

Photograph 10 Tower house (RPS ref 05-09) and former location of the High cross (WI005-070007)

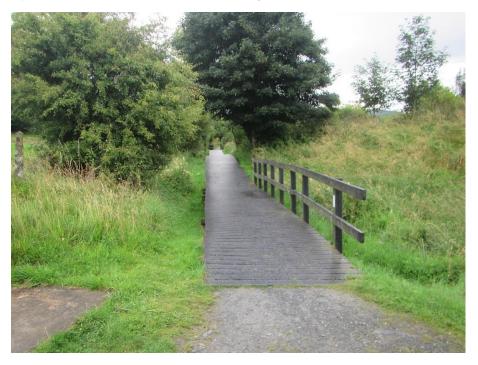
Similarly, the ringwork (WI005-048) is passed by a section of boardwalk which was constructed under archaeological supervision with nothing of note observed in 2013 (Photograph 11). This section of the scheme immediately adjacent to the monument will not be changed under the current proposals.

Photograph 11 Boardwalk adjacent to the ringwork (WI005-048)

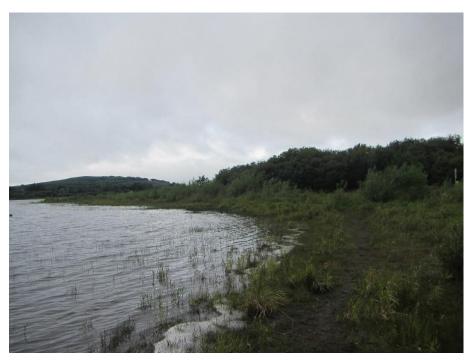
The Greenway continues south to the former Planned Landscape associated with Burgage Moyle Cottage (NIAH 4261). This is described on the NIAH as unrecognisable in its main features. It is heavily wooded and there are no signs of the former cottage. Similarly, Russborough (NIAH 4258) is now described as virtually unrecognisable with its house gone and grounds largely inundated by the reservoir (Photograph 12). In contrast, the planned landscape of Baltyboys House (NIAH 4265) is still extant and clearly visible on the opposite shoreline to the northeast (Photograph 13). The scheme will follow the route of the existing Greenway which is inland extending through Russellstown Wood.

Photograph 12 The shoreline within the former Russborough (NIAH ref 4258) planned landscape

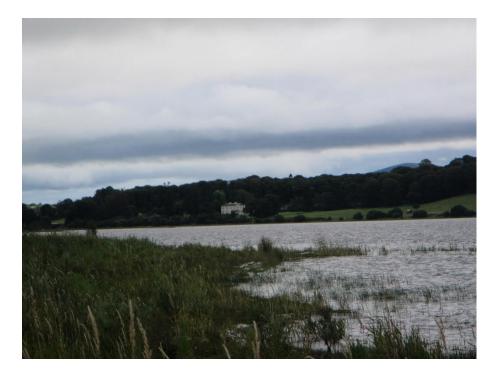
Photograph 13 Looking northeast at Baltyboys with its surrounding planned landscape (NIAH 4265)

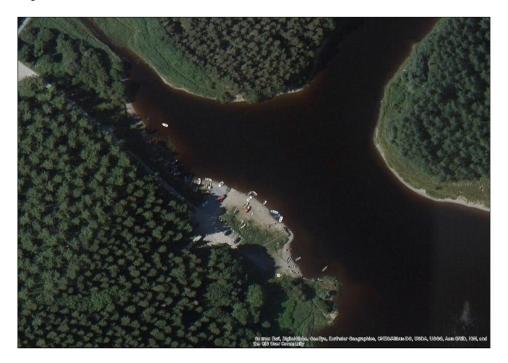
The scheme passes the existing Russborough car park which is situated just off the N81. It is intended that this car park will be extended with provision for 50 additional car parking spaces added. These will be located within the grassed areas either side of the Greenway which continues as a road past the car park (Photograph 14). The Greenway continues southeast providing access to a slipway with a small adjacent car park before turning south and reverting to a trail as it re-enters the forest.

Photograph 14 Overview of the Proposed location of the extension to Russellstown Car Park.

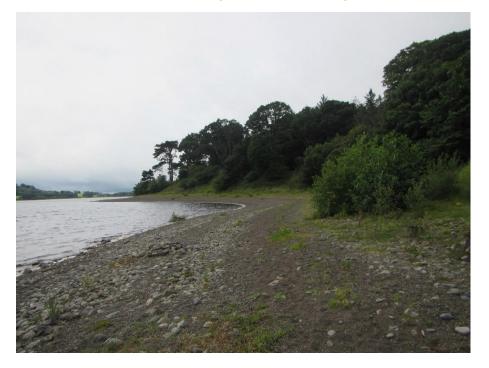
The remainder of the route south largely hugs the shoreline with the adjacent terrain rising steeply to the west. A prominent headland is part of the planned landscape of Russborough House (NIAH ref 4256) although it has been greatly denuded (Photograph 15). The main part of the planned landscape Russborough House (NIAH ref 4256) is located to the north of the N81. It is largely extant with its house intact. It is now open to the public and the scheme will include a connection to Russborough House via an existing tunnel which will be converted.

Photograph 15 Part of Russborough House (NIAH 4256) planned landscape.

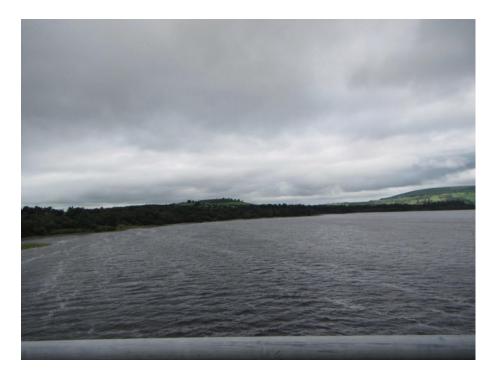
There are no recorded archaeological sites within the study area along the section from Baltyboys to Boystown until close to the bridge leading to Valleymount, where the Neolithic house (WI010-058) is located, submerged just off the shoreline (Photograph 16).

Photograph 16 Shoreline at Boystown where the submerged Neolithic House (WI010-058) is located

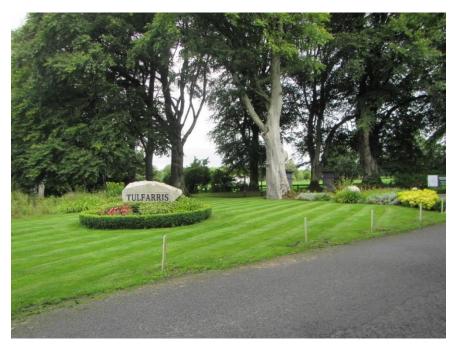
The Tulfarris Loop follows the existing road network northwest to the Tulfarris Golf resort. This is located within the former planned landscape (NIAH 4257) associated with Tulfarris House (Photograph 17). The planned landscape has been greatly denuded by the creation of the reservoir and golf course with the result that it is now barely recognisable.

Photograph 17 Tulfarris Golf resort within former planned landscape (NIAH 4257)

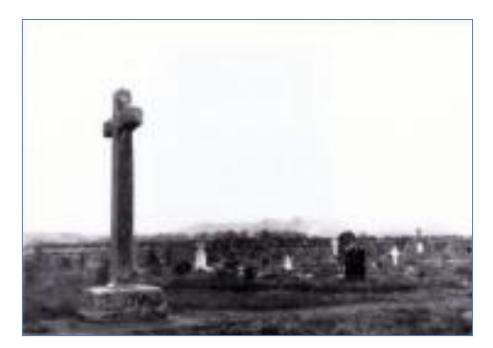
Plate 2 High Cross in its original location at Burgage More re-erected in Blessington town cemetery.

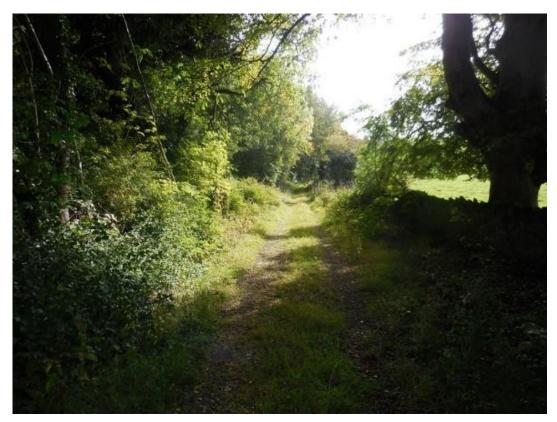
This proposed section extends east from the N81at Russelstown along an existing track known locally as Featherbed Lane (Figure 3). This track originally marked the southern boundary of the no longer extant Russelstown House, the demesne of which was partially inundated by the creation of the reservoir (NIAH Garden Survey Ref. WI-56-N-964111). At the entrance to the track is a wall plaque, a memorial to Father Patrick Jones who died at the spot in 1897 (CHS 2).

Plate 4 Looking south east along Featherbed Lane, edge of Russelstown demesne.

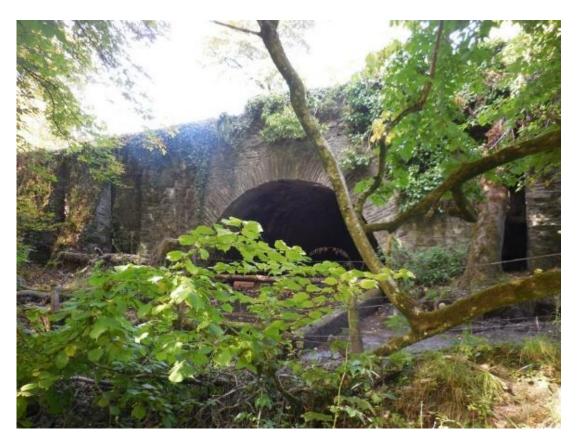
Plate 5 Looking north to unnamed bridge Russborough.

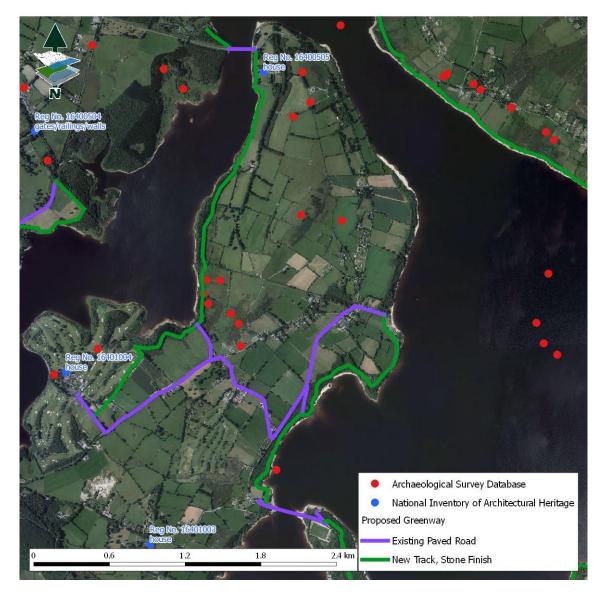
This section extends from Burgage Bridge south along the shore of the reservoir to the west of Boystown or Baltyboys Lower to Tulfarris Golf Club (Figure 4). As throughout the project the track will largely follow a margin of land along the shoreline of the reservoir in the ownership of the ESB. For the most part this margin is under forestry. The significant cultural heritage sites in this area from north to south are Baltyboys House and two enclosures located to the east of the margin (RMP No's WI010-003005 & 003006).

Figure 4 Aerial Image showing Tulfarris Spur and the Tulfarris to Blessington Sailing Club route.

From the entrance to Tulfarris Hotel and Golf Resort it is proposed that a section of the route follows along the existing road to the north east, diverting west past the entrance to Blessington Lakes Golf Club and then north along the R758 to Blessington Sailing Club (figure 4-purple route). This section will utilise existing carriageways with no recorded monuments or protected structures along the way. The road does pass to the west of Stormount House Demesne (NIAH Garden Ref: WI-56-N-975092) described as having its main features unrecognisable - peripheral features visible. The roadside boundary for this demesne is made up off a low stone wall and hedgerow. It is not proposed to carry out any works along this route.

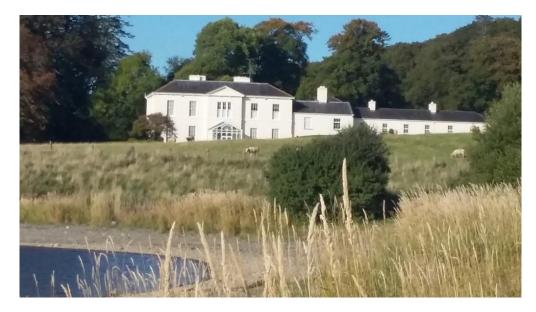
Plate 6 Looking north to Baltyboys House from the shoreline.

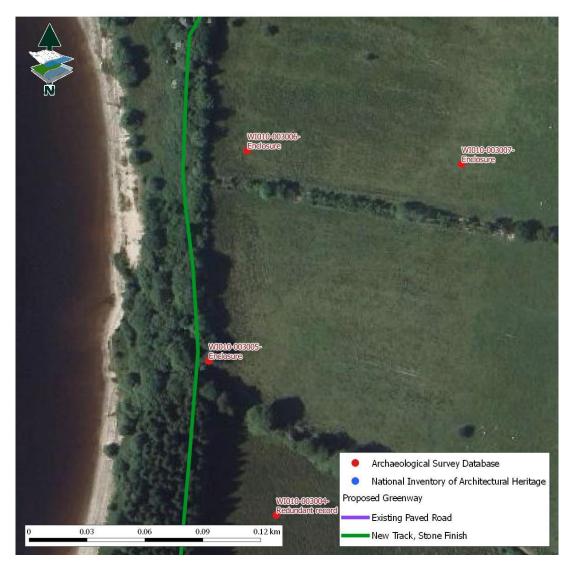
To the south of Boystown/Baltyboys Upper there are two enclosure sites to the immediate east of the forested margin in marshy ground at the base of a hill (figure 5). The proposed track will pass within the 'Zones of Notification' for these sites. These enclosures were originally identified from circular cropmarks visible on an aerial photograph (GSI N 332/333/356 (1973)). The sites are located at the base of a hill in marshy ground. Field working in this area found no visible trace of either site above ground.

Figure 5 Enclosure sites at Boystown, there was no above ground trace of either site identified from aerial imagery.

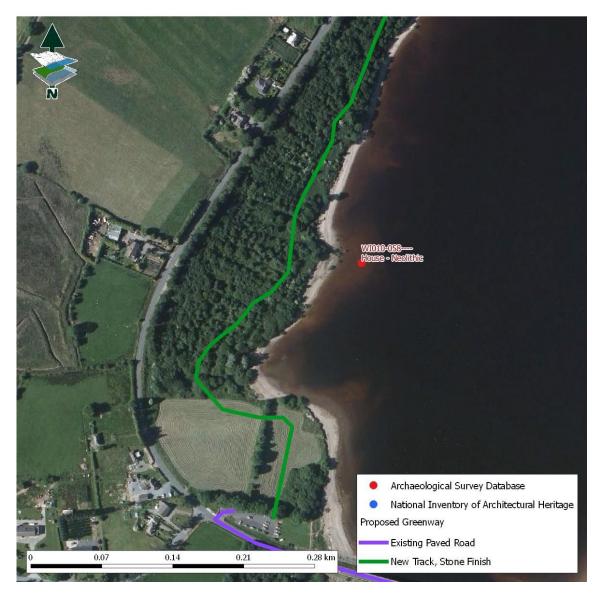
It is proposed that this section from Blessington Sailing Club will run along the eastern shoreline of Boystown or Baltyboys Upper towards Valleymount Bridge through existing forestry (figure 6). There is one RMP along the shoreline classified as a Neolithic House (WI010-058). This site was identified in 2006 when the level of the reservoir was low. The prehistoric house comprised an almost square structure defined by the burnt clays and charcoal-rich fill of the slot-trench of the building's foundation (int. dims. L 6.6m N-S; Wth 6.2m E-W). Significantly subsequent intermittent investigations (Excavation Licence No. 07E1127) revealed a significant amount of Neolithic pottery, a flint axe and a possibly ritually deposited Bann flake (Corlett 2009, 26-30). The house site is located 65m east of the proposed trackway. Given the significant nature of the material discovered this area has to be considered to be of high archaeological potential.

Figure 6 Location of Neolithic House relative to proposed trackway.

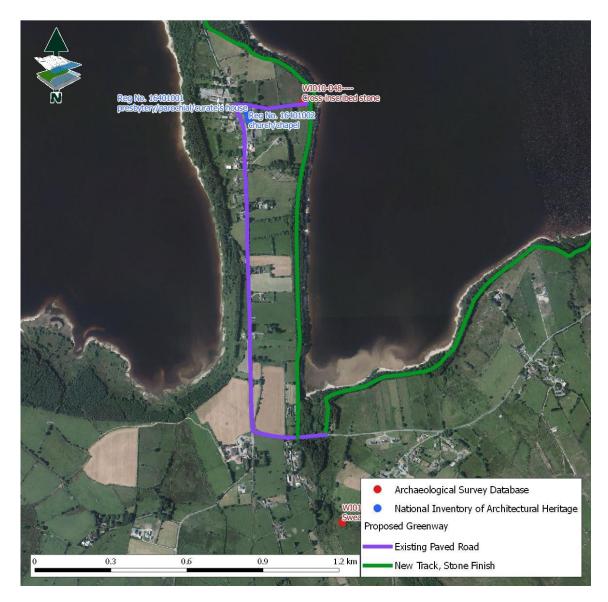
The Valleymount Loop comprises two sections, one follows the R758 roadway south through Valleymount towards Annacarney, the other is a proposed trackway through forestry along the eastern shoreline of the townland (figure 7). Along the road section in Valleymount there are a number of Protected Structures including St. Joseph's R.C. Church, the Parochial House and Valleymount House (RPS Ref 10-21, 10-22 and 10-23 respectively). A lane linking the loop from the roadway to the track on the shoreline will pass RMP WI010-048 classified as a cross inscribed stone. This granite boulder located on the north side of a lane that originally linked Valleymount to Ballyknockan comprises a small double-line incised Latin cross (L c. 0.4m. that probably dates to the late 18th century.

Figure 7 Valleymount Loop showing recorded sites.

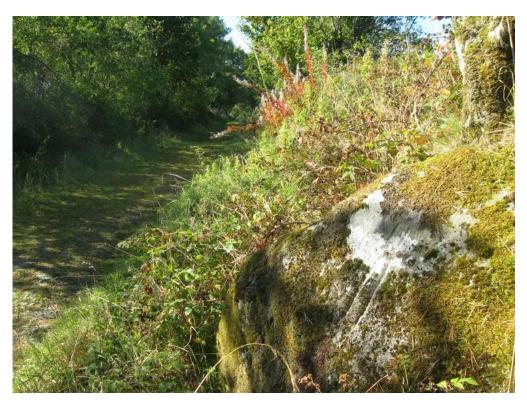
Plate 7 Cross inscribed stone RMP WI010-048 along laneway at Valleymount.

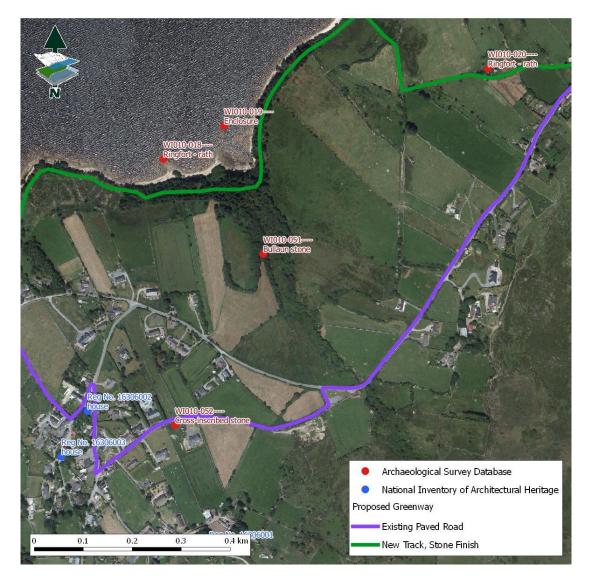
North of this site is another submerged enclosure (WI010-019) that was also featured on the 1838 OS 6inch map. This site is occasionally exposed in dry summer and is 70m from the track. In Ballynastockan townland it is proposed to develop a spur from the shoreline that will cross through fields to the east and connect with a farm lane and thence Lake Drive road. The farm lane skirts the edge of a 'D' shaped ringfort partially revetted with boulders (WI010-020). There is no evidence of a fosse and internally the site has no features other than a number of natural boulders.

Figure 8 Location of recorded sites at Ballyknockan/Ballynastockan.

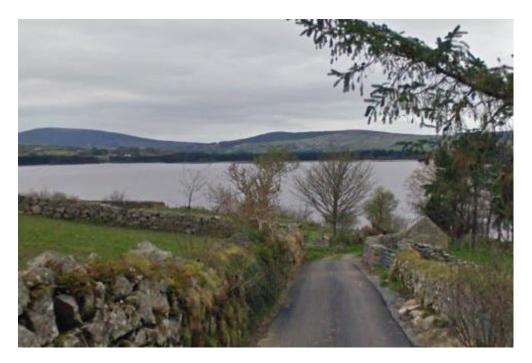
Along the existing route (purple route) there are a number of notable features including a protected structure known as' Biddy Mulvey's Cottage' (RPS 10-5). This site is located at the end of a lane known locally as 'the Bog Road' that leads to the shore (ITM 700306 E/ 707514 N). It survives as a coursed-rubble granite gable with an inset plaque that reads 'The Emergency Land Grabber Defeated here 1888, God Save Ireland'. The story of the plaque relates to the forcible eviction and levelling of the cottage in 1888 by a local landowner. The local land League halted the process by twice rebuilding the house and winning a court case to ensure her tenure. Within Ballyknockan there are also number of protected structures mostly vernacular dwellings and sheds (RPS 10-16 & 15). East of the village the route follows a lane that bypasses a cross inscribed boulder along a stone wall WI010-052. The boulder (dims. 1.45m x 1m) is inscribed on the front face with 'IHS' and a simple cross. Other incised marks occur on the flat upper surface. There are no proposed works along the purple route.

Looking west towards Biddy Mulvey's Cottage in Middleground.

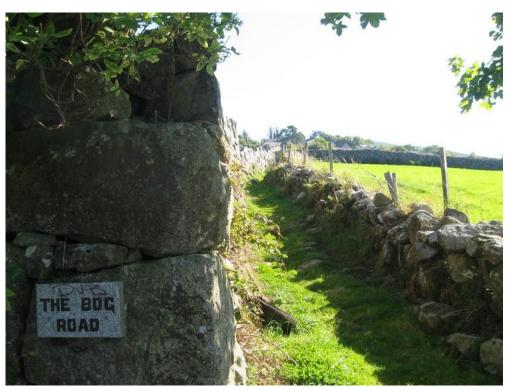
Plate 9

The old bog road opposite Biddy Mulvey's Cottage

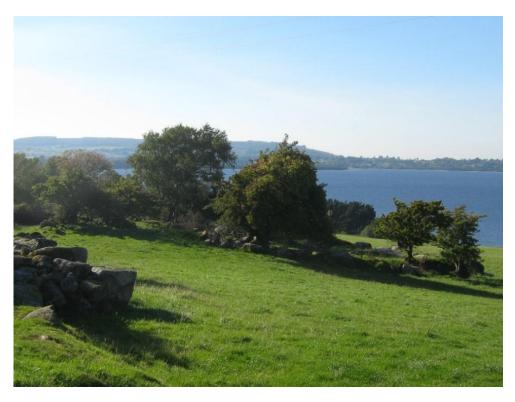
Plate 10 Looking west to Ringfort at Ballynastockan WI010-020

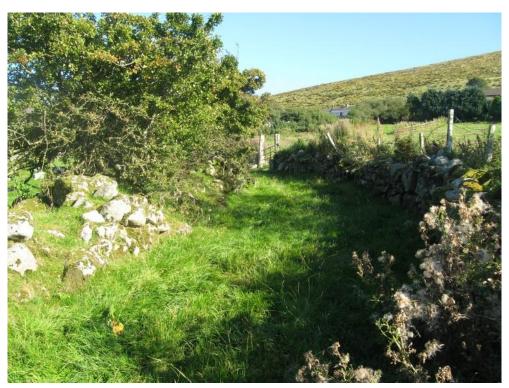
Plate 11 Lane skirting edge of Ringfort at Ballynastockan WI010-020.

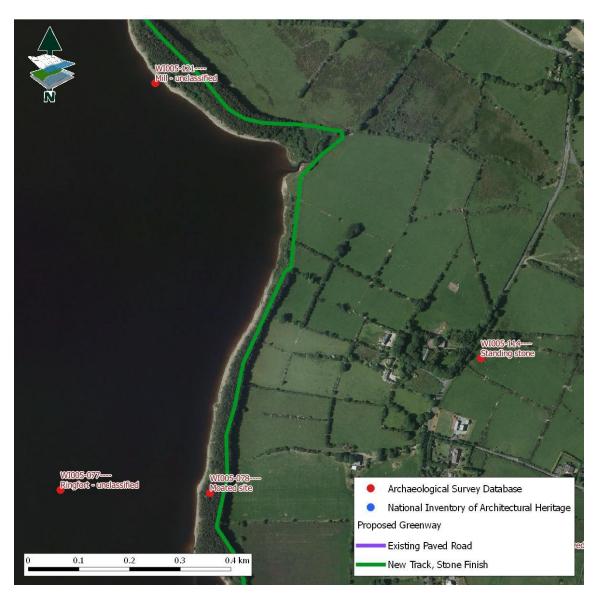
Figure 10 Image showing Mill site at Burgage More and Moated site at Carrig.

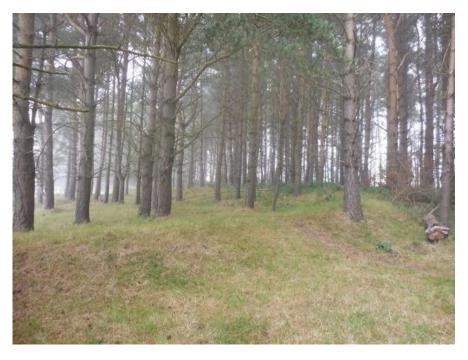
Plate 13 Looking east along the bank of moated site

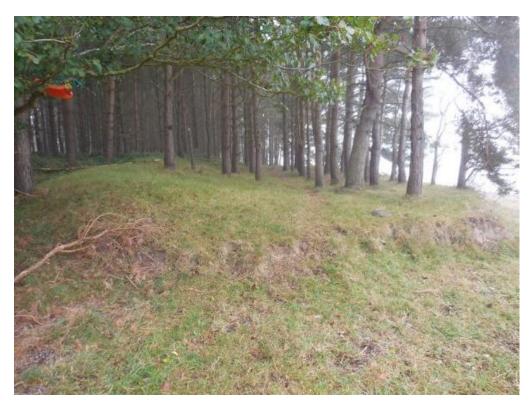
Plate 14 Looking south at scarp edge off Moated site.
